Date and Time: 9/26/2022 11:43 AM **Legal Name:** FOOTHILL COLLEGE

Inspection No: 2016090000816126 **Facility Name:** FOOTHILL COLLEGE

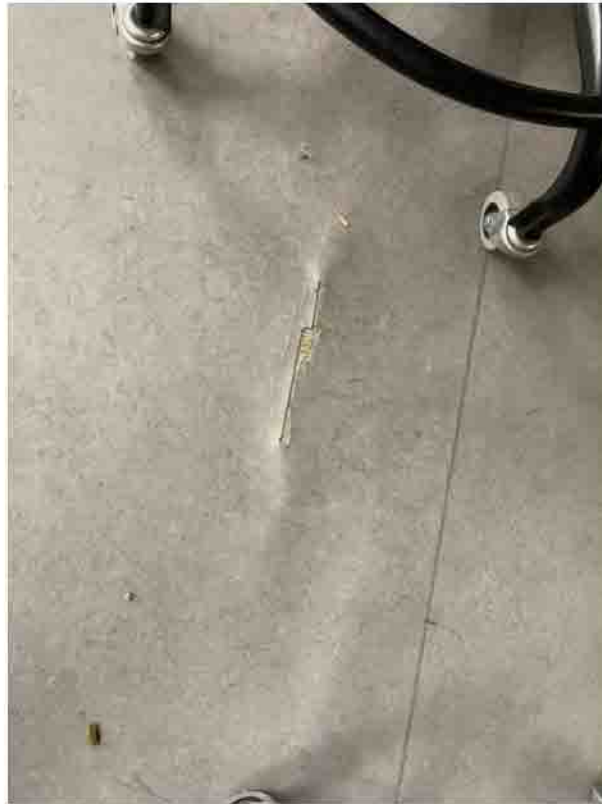
CFR:3.2(d)

Description: Bubbled, cracked and missing flooring
