Inspection Report

ENVIGO GLOBAL SERVICES INC

Type: FOCUSED INSPECTION

Date: 16-NOV-2021

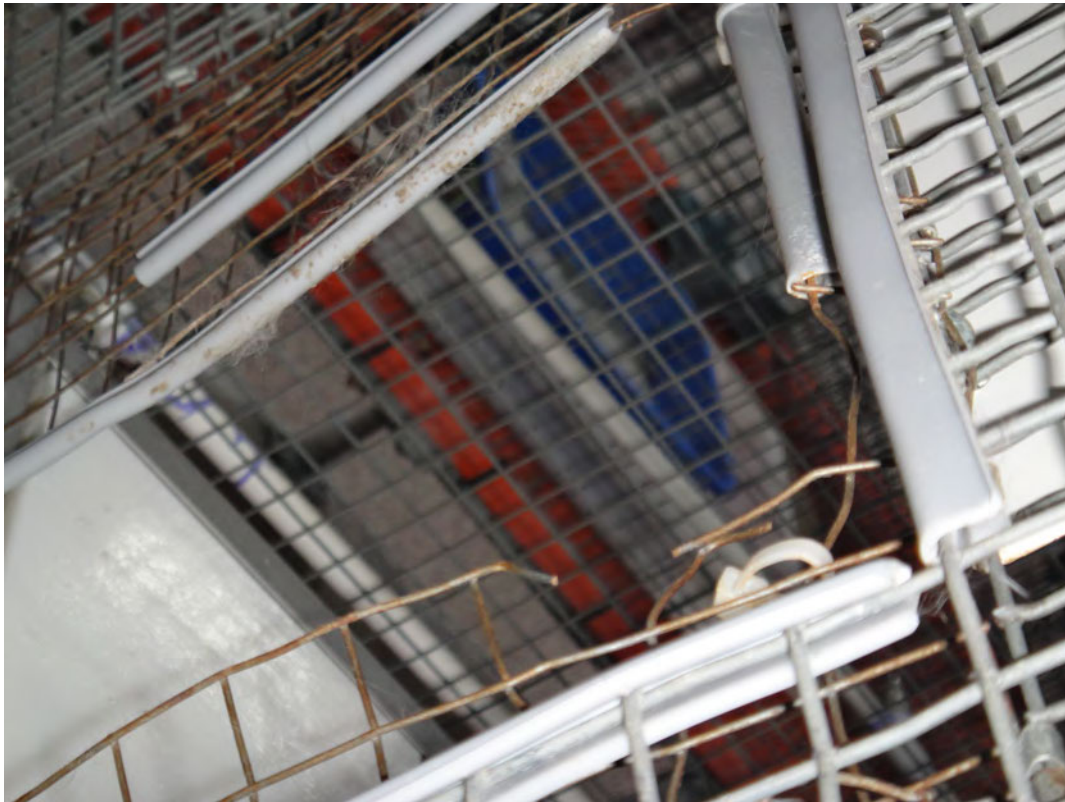
CFR:3.1(a)

The facility has twenty-four cats housed together in Building 97-15. Multiple welded wire mesh enclosures are attached together, and the cats have access to all of them by moving through openings cut into the wire panels. Numerous sharp points created by wires that have cut to create the openings in the enclosures. The sharp points are along the bottom of the openings and the inspectors observed the cats stepping on the sharp points as they moved through the enclosure opening. Additional broken wires are located near one of the automatic waterers. The damaged wires are at the level of the animals and the cats have the ability to come into direct contact with these sharp points.

Sharp points and edges could cause injury to the cats should they come into direct contact with them. Gaps in the flooring and fencing can cause injury to the cats should they place parts of their bodies through the openings.

Description: Building 97 Room 16: Sharp metal points (copper metal) at a juncture between wire enclosures. Sharp edges are located directly in the hole that cats use to transfer from enclosure to enclosure.

Housing facilities for cats must be constructed and designed so they are structurally sound, kept in good repair and protect the animals from injury. The licensee must alter the sharp points in a manner that eliminates the risk of injury to the cats. The licensee must ensure that all aspects of the enclosures are maintained in good repair and are safe for the animals at all times. To be corrected by: 18 February 2021

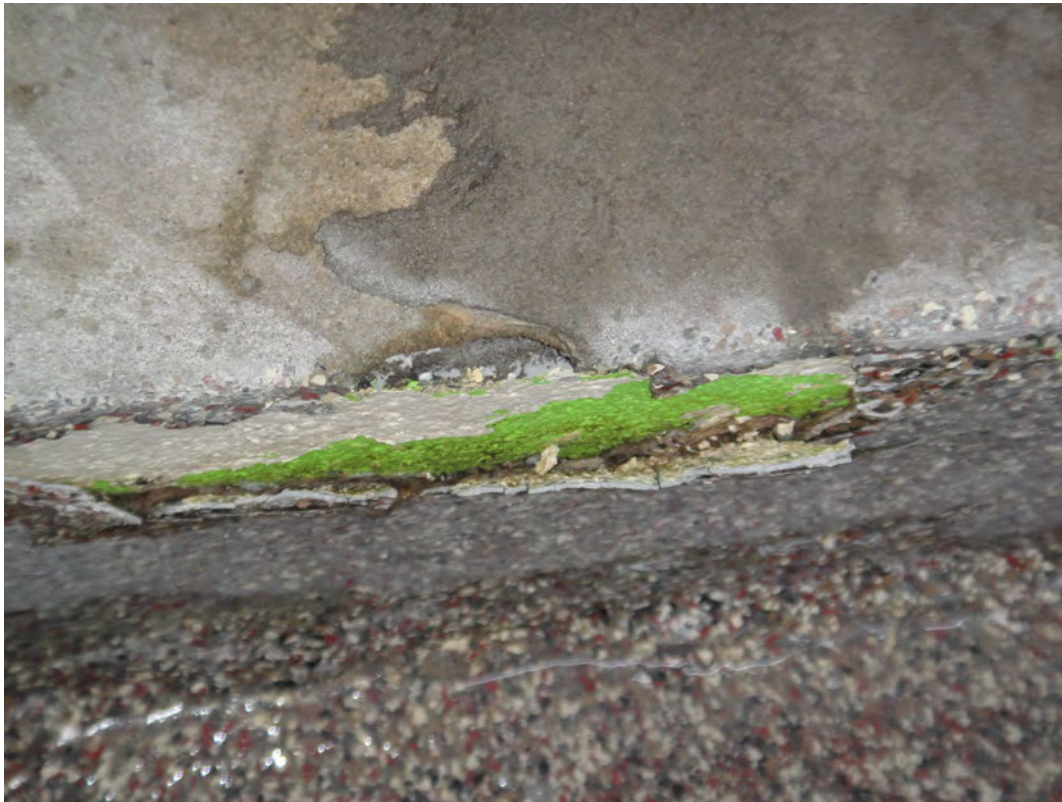
CFR:3.2(d)

The indoor housing areas in Building 97 Rooms 15, 16, and 17 which house cats have numerous surfaces that are not impervious to moisture. In all rooms there are extensive areas along the junction of the wall and floor where large patches of epoxy have peeled off the underlying concrete exposing the unsealed concrete. Additionally, there are patches where the concrete has also chipped and broken. This is worst in rooms 15 and 17 where the concrete flooring under the enclosures / concrete drains are broken, cracked and crumbling. The entire concrete drain areas under the raised cat enclosures appear damp in some spots. There are areas of the walls which paint is flaking off. Although these areas are not in direct contact with the animals, the areas of unsealed floor can become saturated with moisture during routine cleaning and disinfection. Additionally, the numerous cracks and cervices created by the peeling paint and epoxy create areas that cannot be adequately cleaned and sanitized.

Surfaces that are not impervious to moisture and those which are cracked and crumbling cannot be properly cleaned and sanitized which could increase the risk of disease hazards towards the cats. Absorption of water could also undermine a surface's structural integrity causing it to fail and potentially injure an animal.

Description: Building 97 Room 16: Close-up of cracked concrete / missing epoxy floor cover with chipped edges.

Surfaces of indoor housing facilities, including floors and walls, must be impervious to moisture. The licensee must

ensure that the affected surfaces are sealed or painted in a manner that makes them impervious to moisture. The licensee must also ensure that all surfaces are appropriately maintained at all times in order to support the health and well-being of the animals. To be corrected by: 18 February 2021.

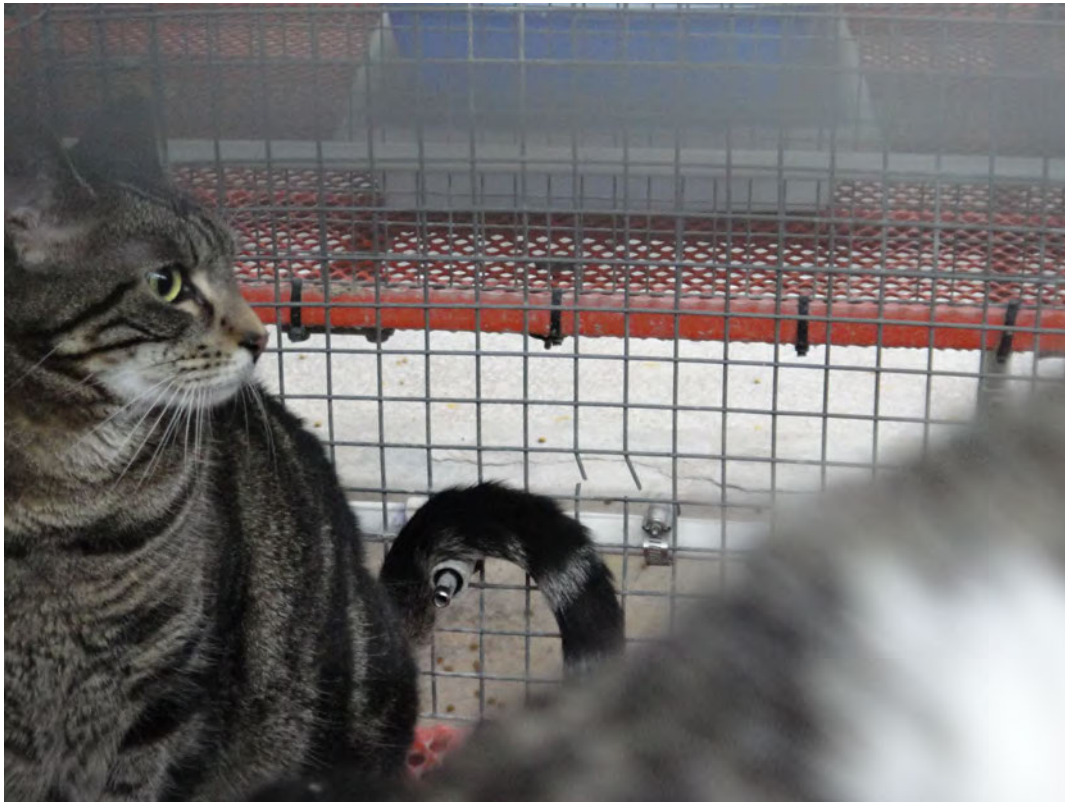
CFR:3.1(a)

Description: Building 97 Room 15: Sharp points of broken wire mesh enclosure located just above and to the right of the lixit water supply.

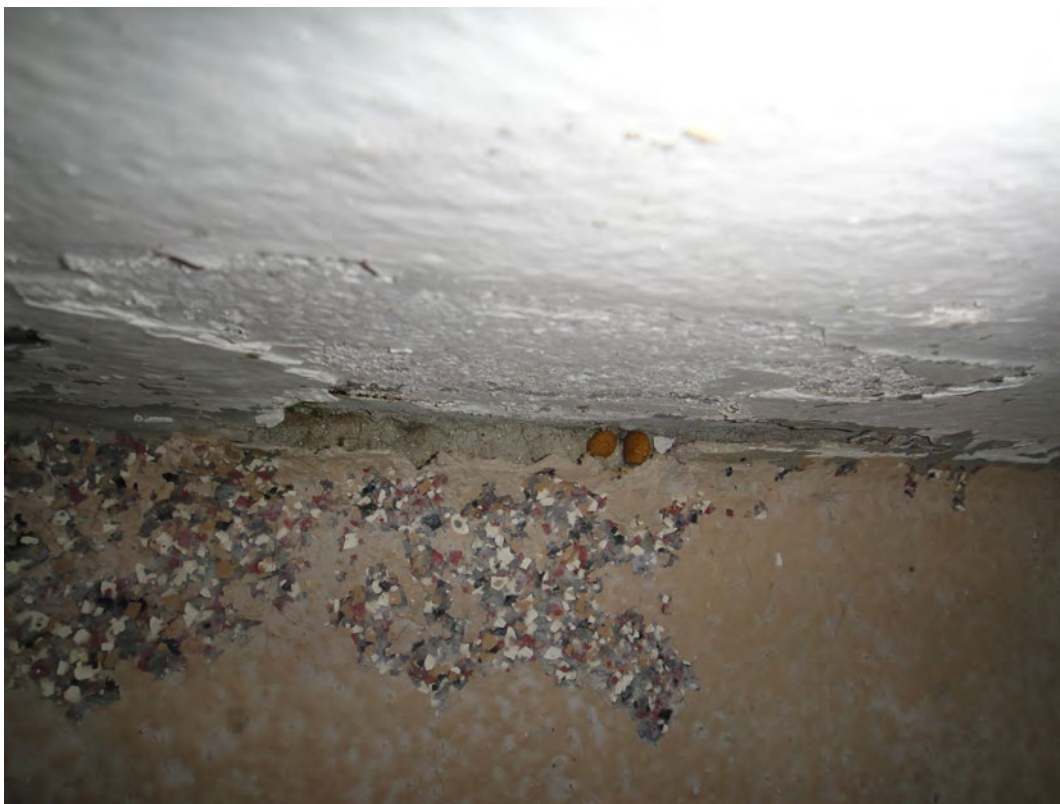
CFR:3.2(d)

Description: Building 97 Room 15: Chipping and flaking paint

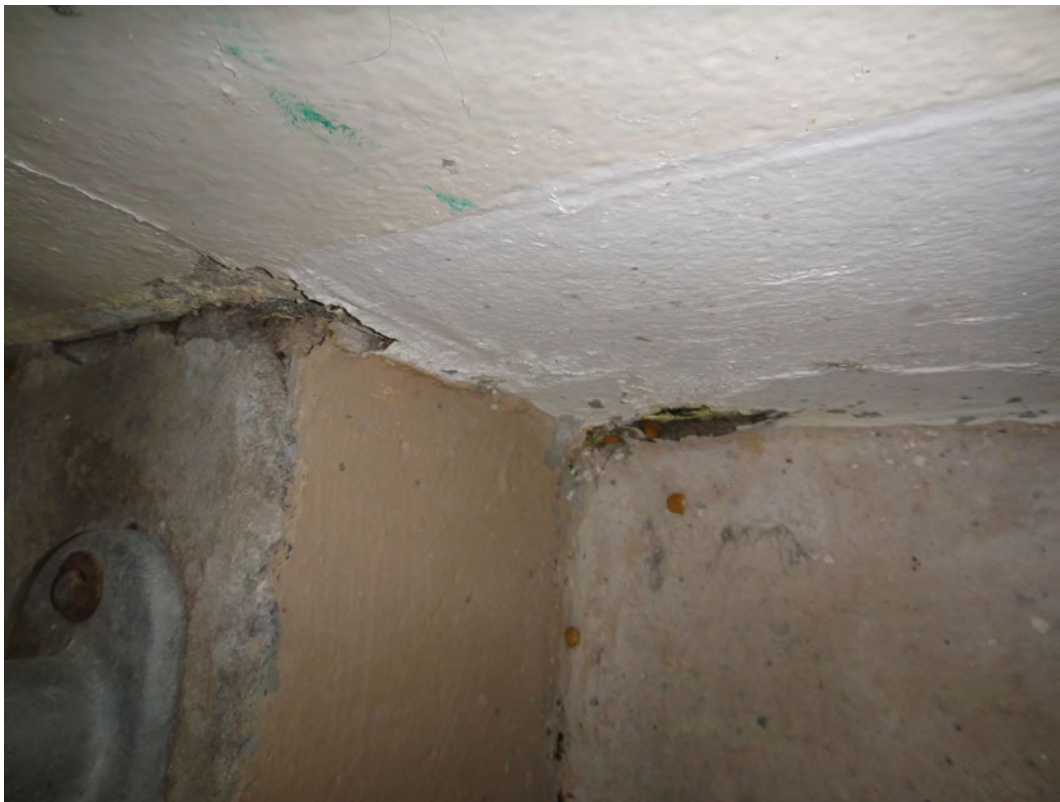
CFR:3.2(d)

Description: Building 97 Room 15: Chipping and flaking paint

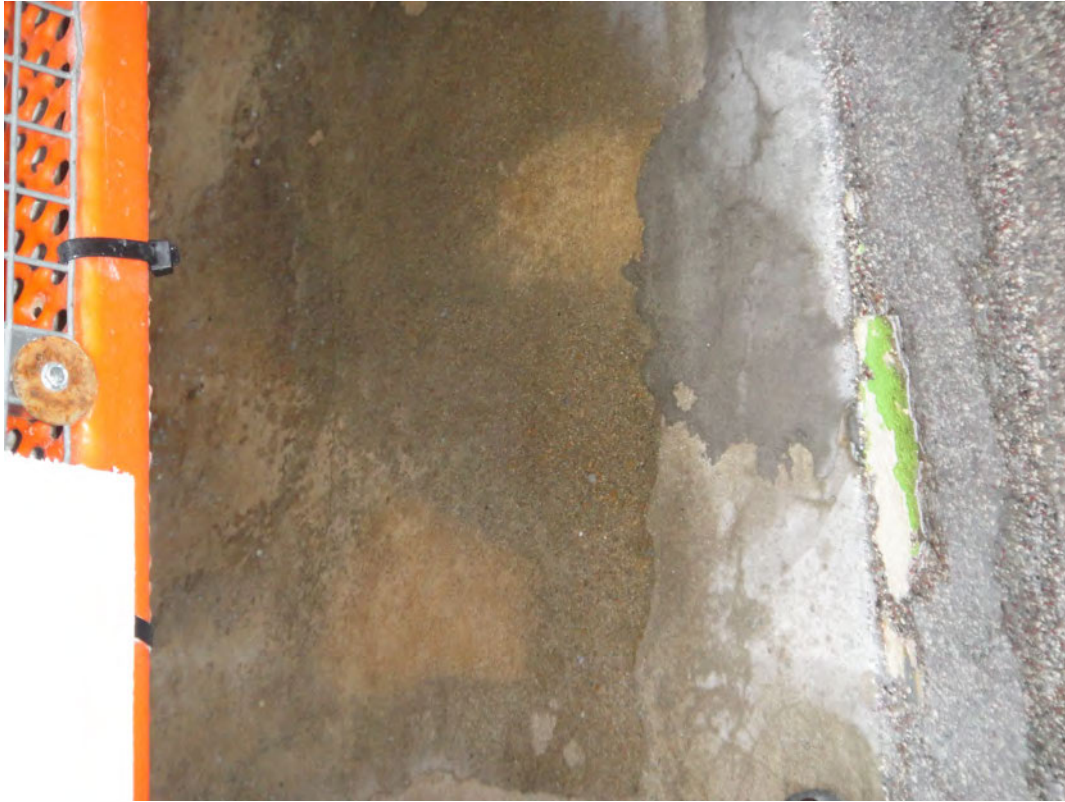
CFR:3.2(d)

Description: Building 97 Room 16: Cracked concrete / missing epoxy floor cover with the underlying layer present (green/yellow in color).

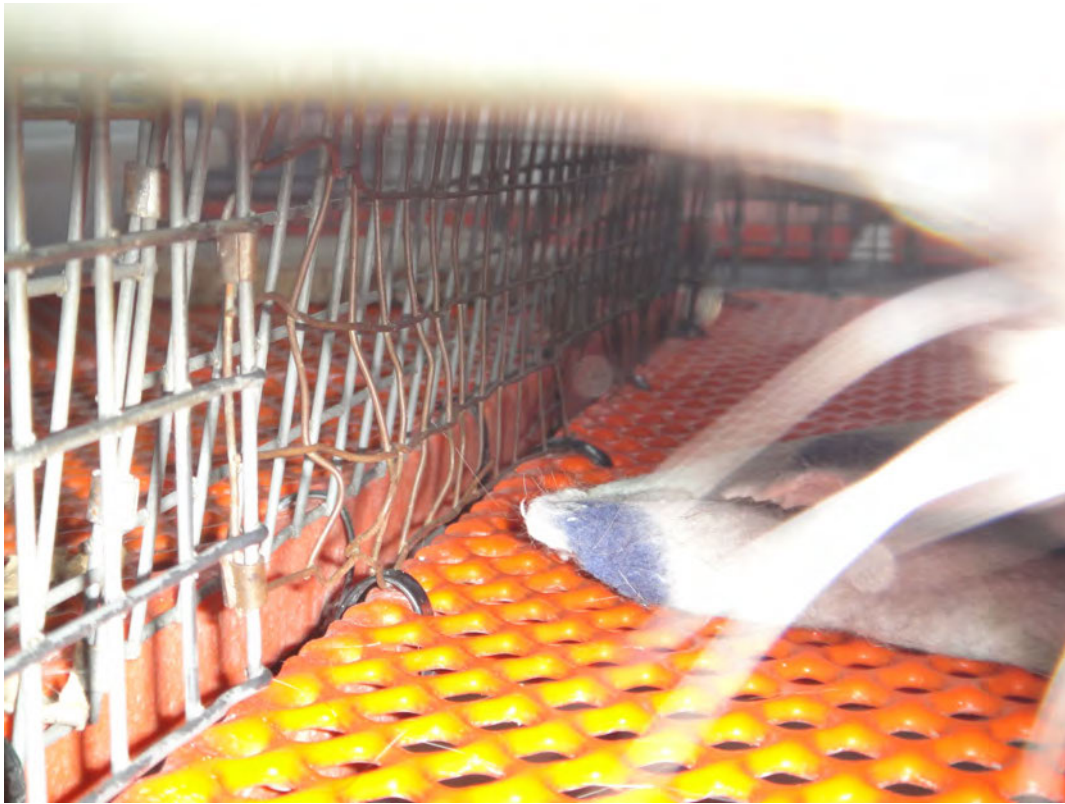
CFR:3.1(a)

Description: Building 97 Room 16: A sharp piece of metal located right along the floor of the enclosure (copper wire) and angled into the enclosure. Note the sharp edge is at about 10-11 o'clock from the very tip of the blanket.

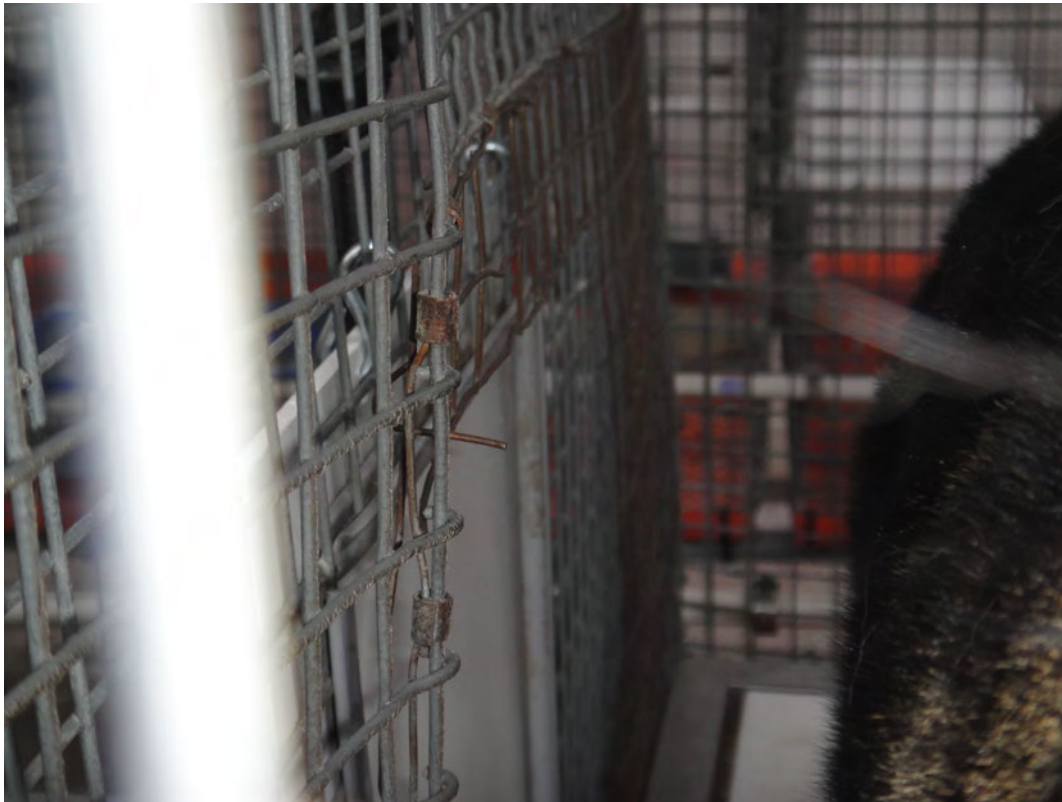
CFR:3.1(a)

Description: Building 97 Room 16: Sharp point from wire mesh at a junction between two rectangular enclosures. This sharp point is pointing directly into the enclosure and near eye level.

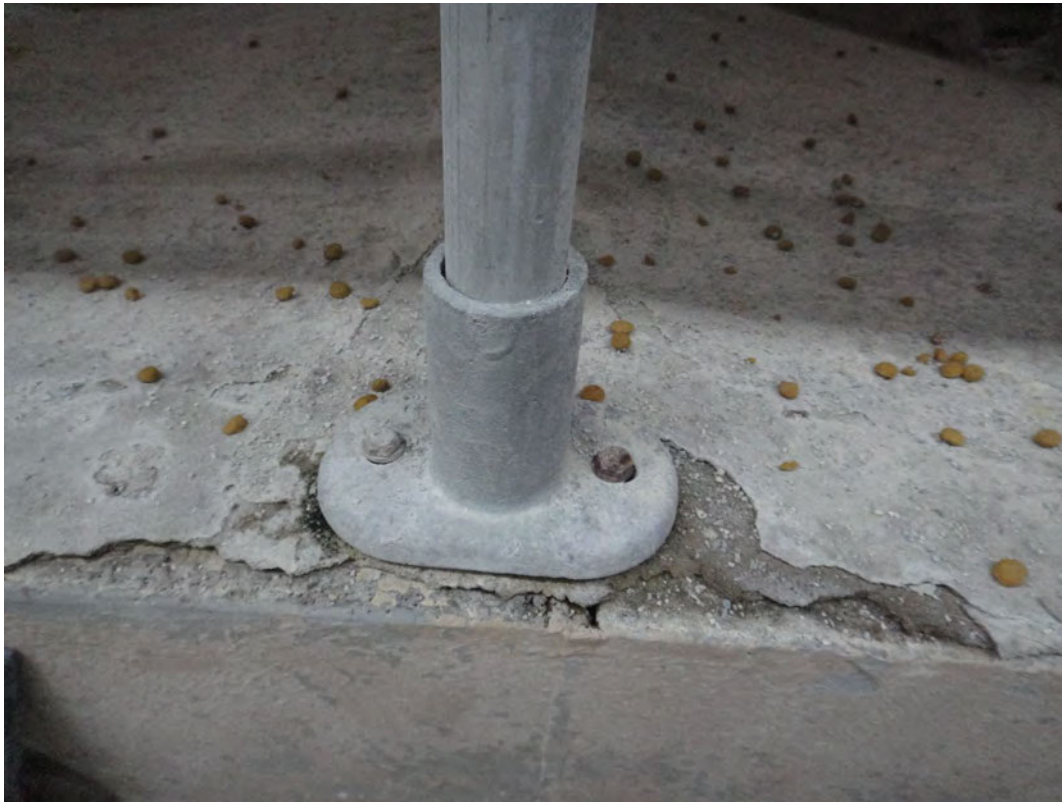
CFR:3.2(d)

Description: Building 97 Room 15: Crumbling and cracking concrete around a post that supports the cat enclosures above. Note the darker color concrete which appears to be retaining moisture due to the compromised surface.

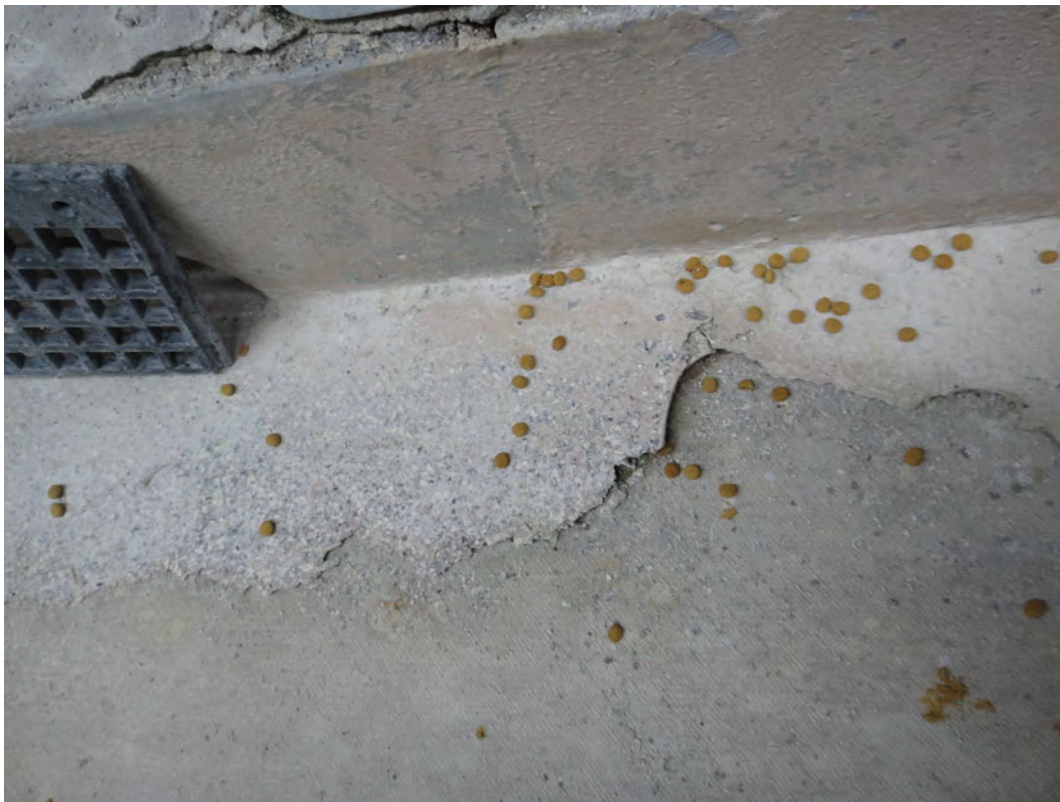
CFR:3.2(d)

Description: Building 97 Room 15: Cracked, uneven edges of concrete

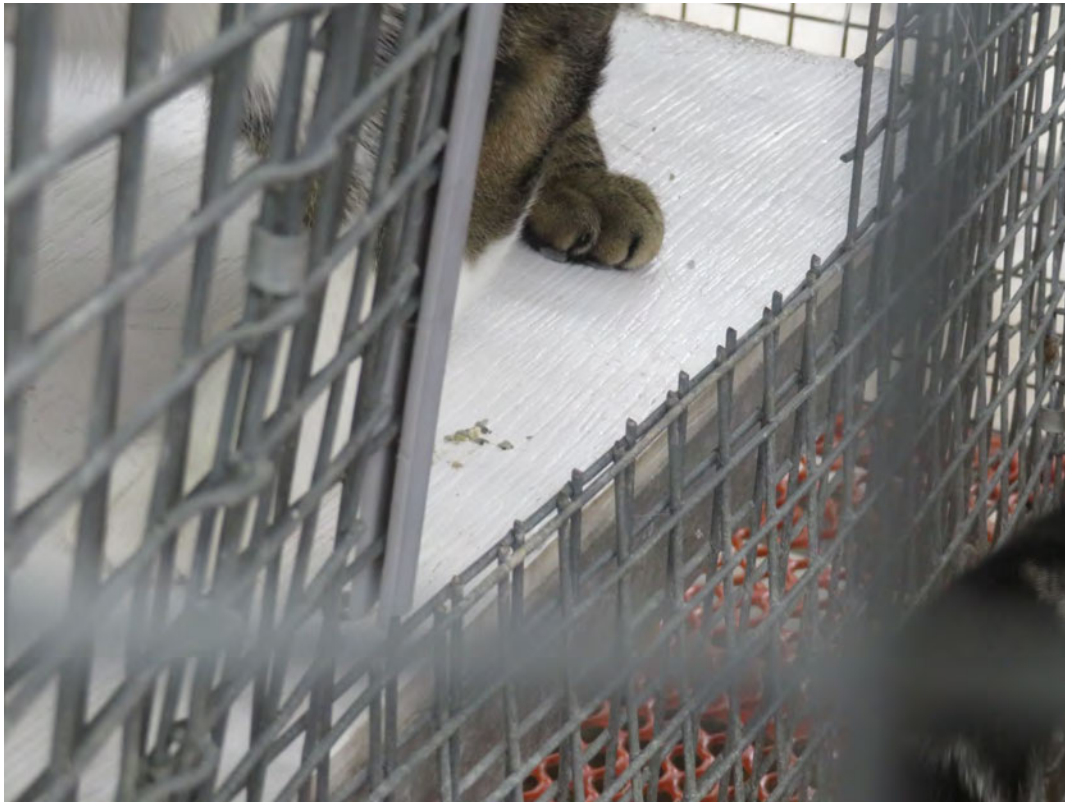
CFR:3.1(a)

Description: Building 97 Room 16: Picture of sharp points at a junction between metal enclosures of the loop. Multiple junctures had sharp wires where a hole was cut out and protruded into the enclosure where the cats traveled.

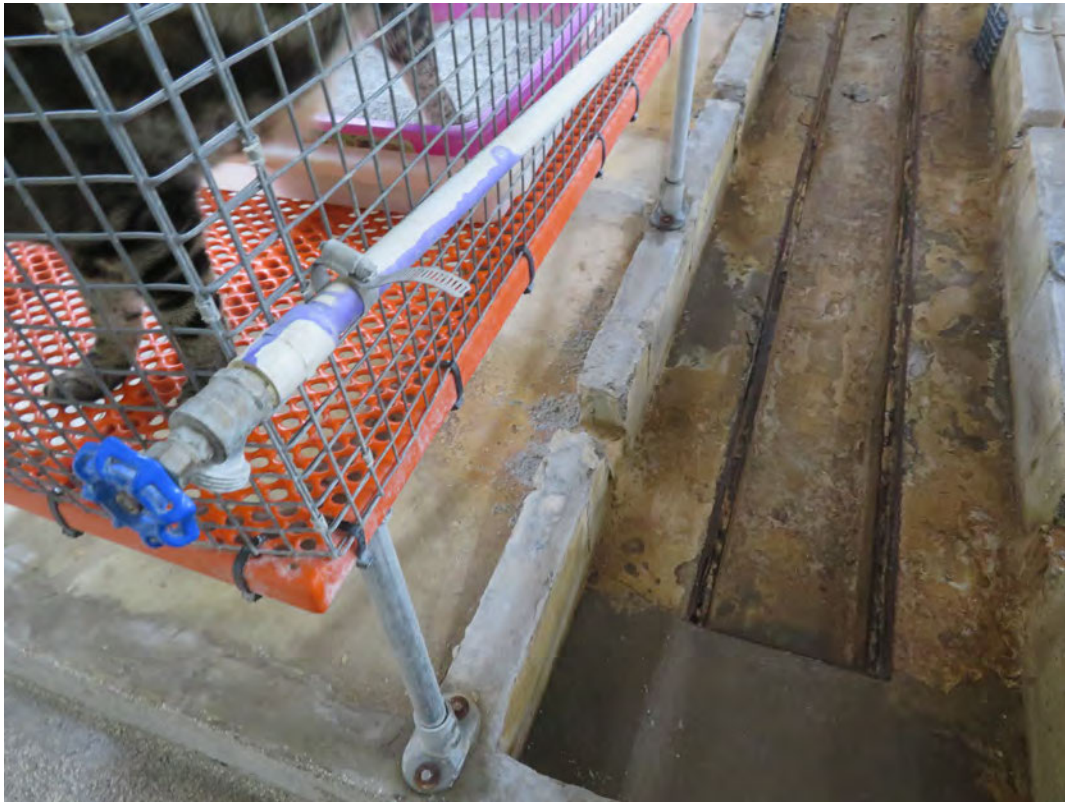
CFR:3.2(d)

Description: Building 97 Room 16: Picture of crumbling concrete underneath the cat enclosures. Note that the concrete crumbling is part of the structure supporting the enclosures.

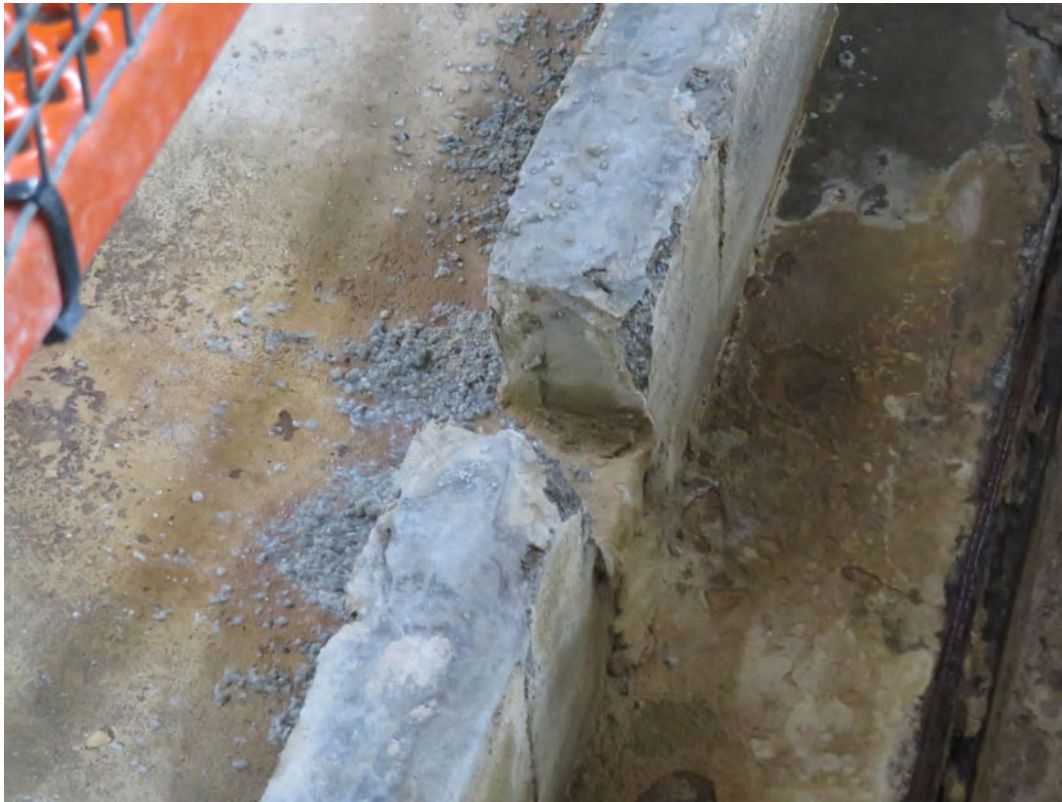
CFR:3.2(d)

Description: Building 97 Room 16: Crumbling concrete underneath the cat enclosures

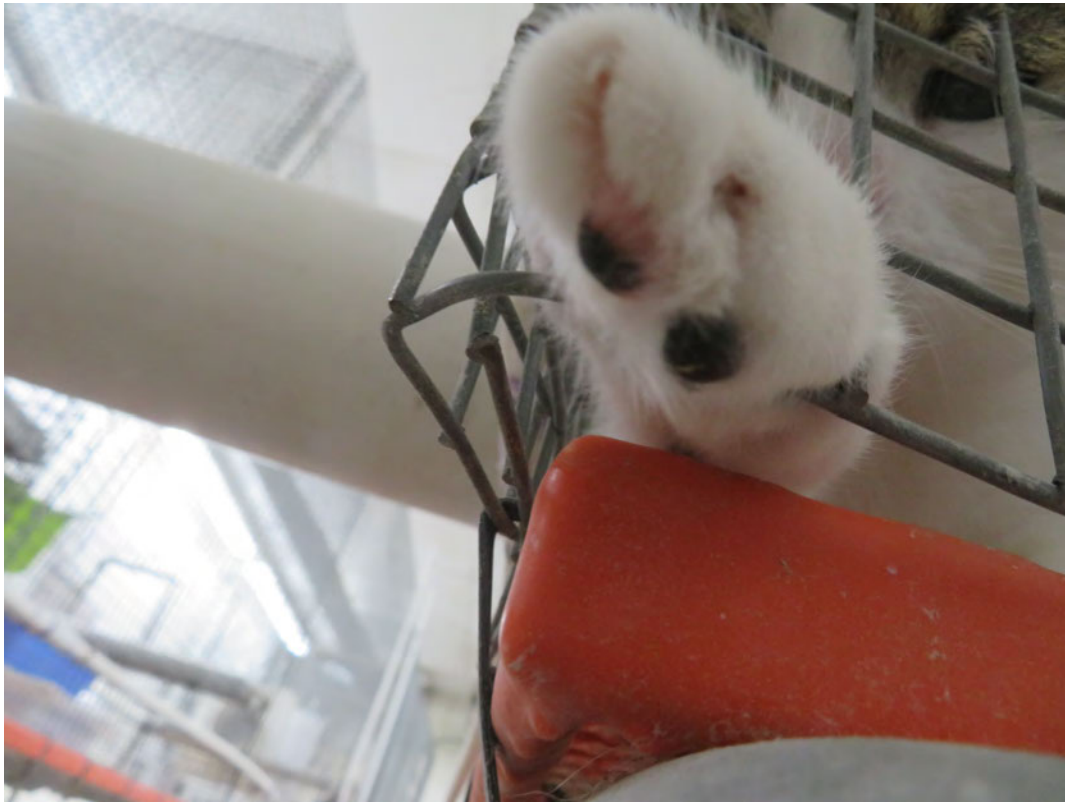
CFR:3.1(a)

Additionally, these same wire mesh enclosures are constructed with both wire floors and walls. One in one corner the wire panels that are used to build the enclosure are not of matching sizes. The enclosure walls and floor therefore are compressed tightly enough together resulting in the fencing of the walls which overhangs the flooring and creates a gap large enough for a cat to place its leg through.

Description: Building 97 Room 16: Picture of gap between enclosure wall and flooring. Note the cat paw and limb that easily fits through the gap.

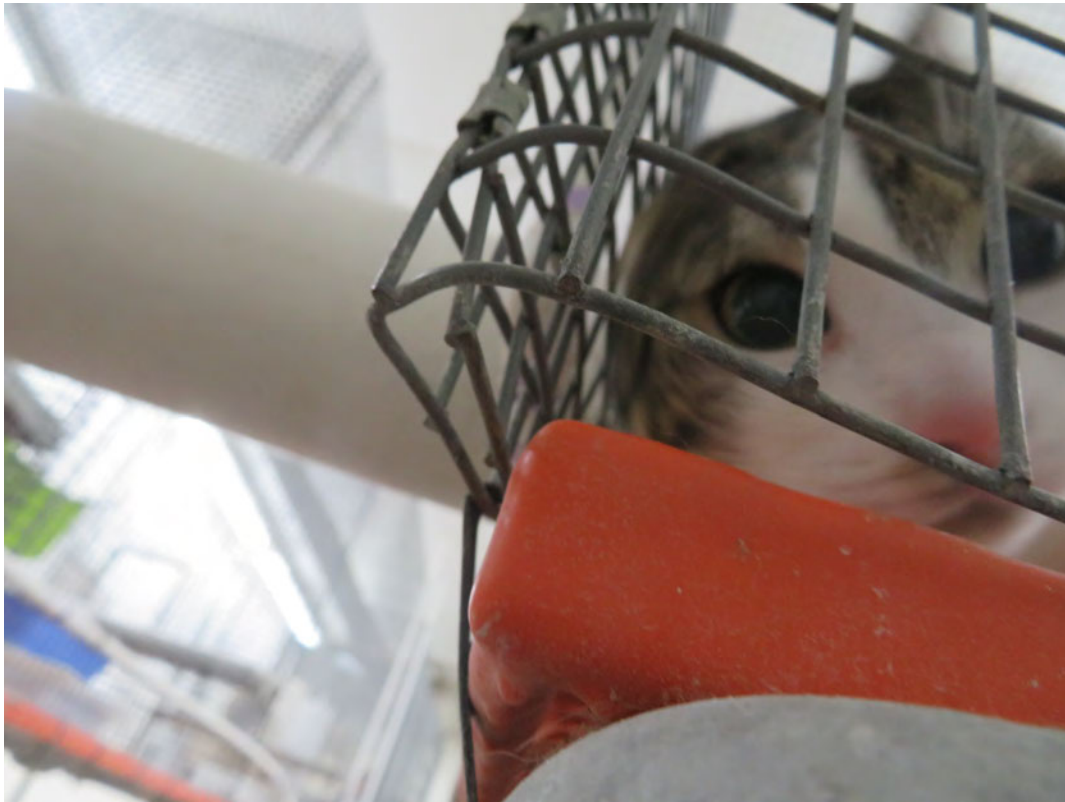
CFR:3.1(a)

Description: Building 97 Room 16: Picture of a gap between the floor and wall of the cat enclosure. Note the hole is big enough for a paw to reach through.

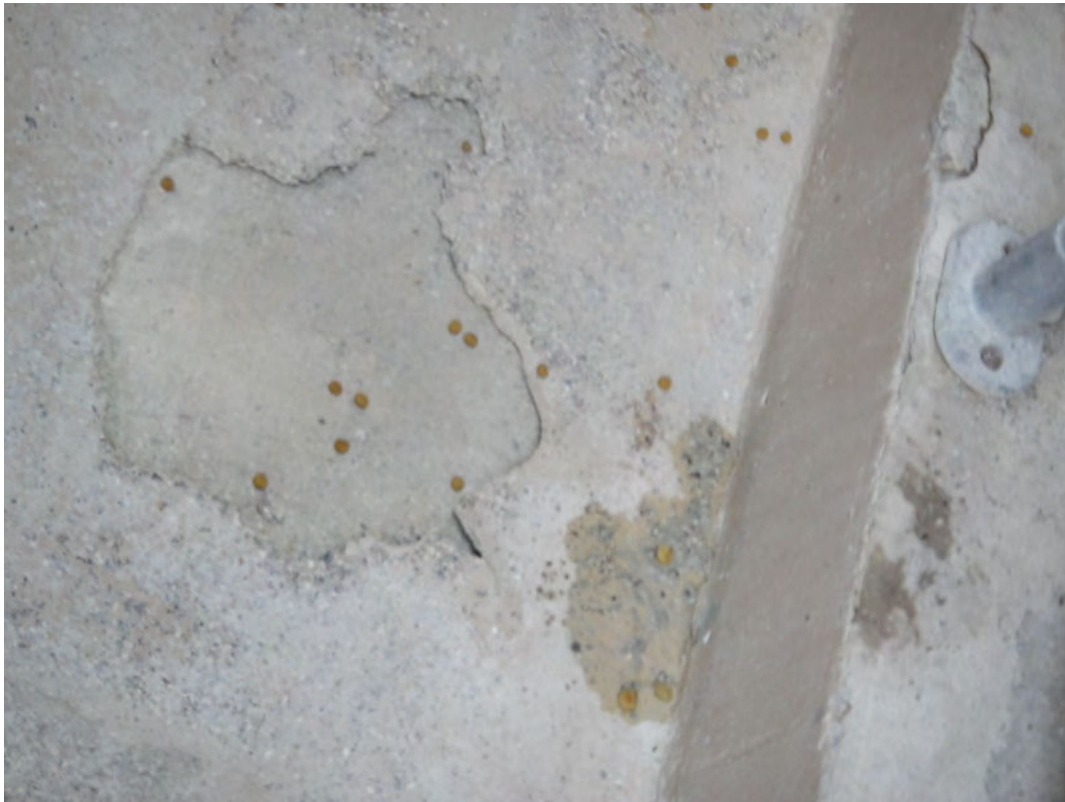
CFR:3.2(d)

Description: Building 97 Room 15: Cracked, uneven edges of concrete

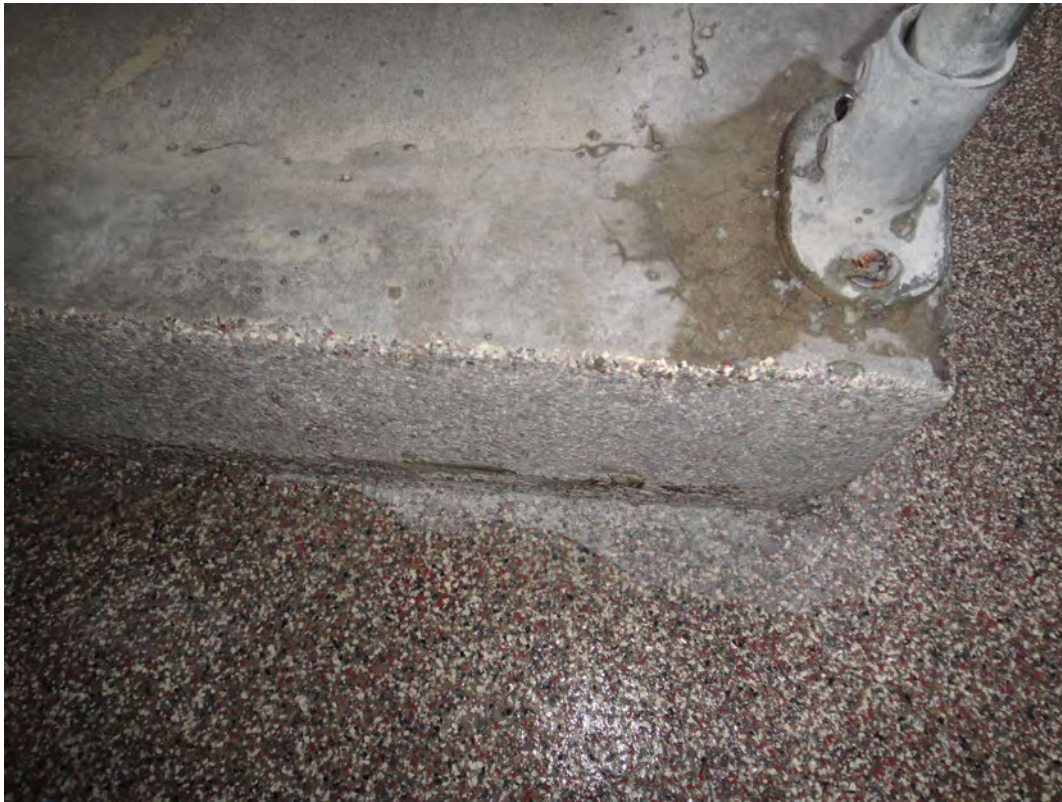
CFR:3.2(d)

Description: Building 97 Room 16: Cracked concrete around a post that supports the cat enclosures above. Note the darker color concrete which appears to be retaining moisture due to the compromised surface.
