Inspection No: 2016082569594130

Certificate: 93-R-0193

DAVID R YOUNG D.V.M.

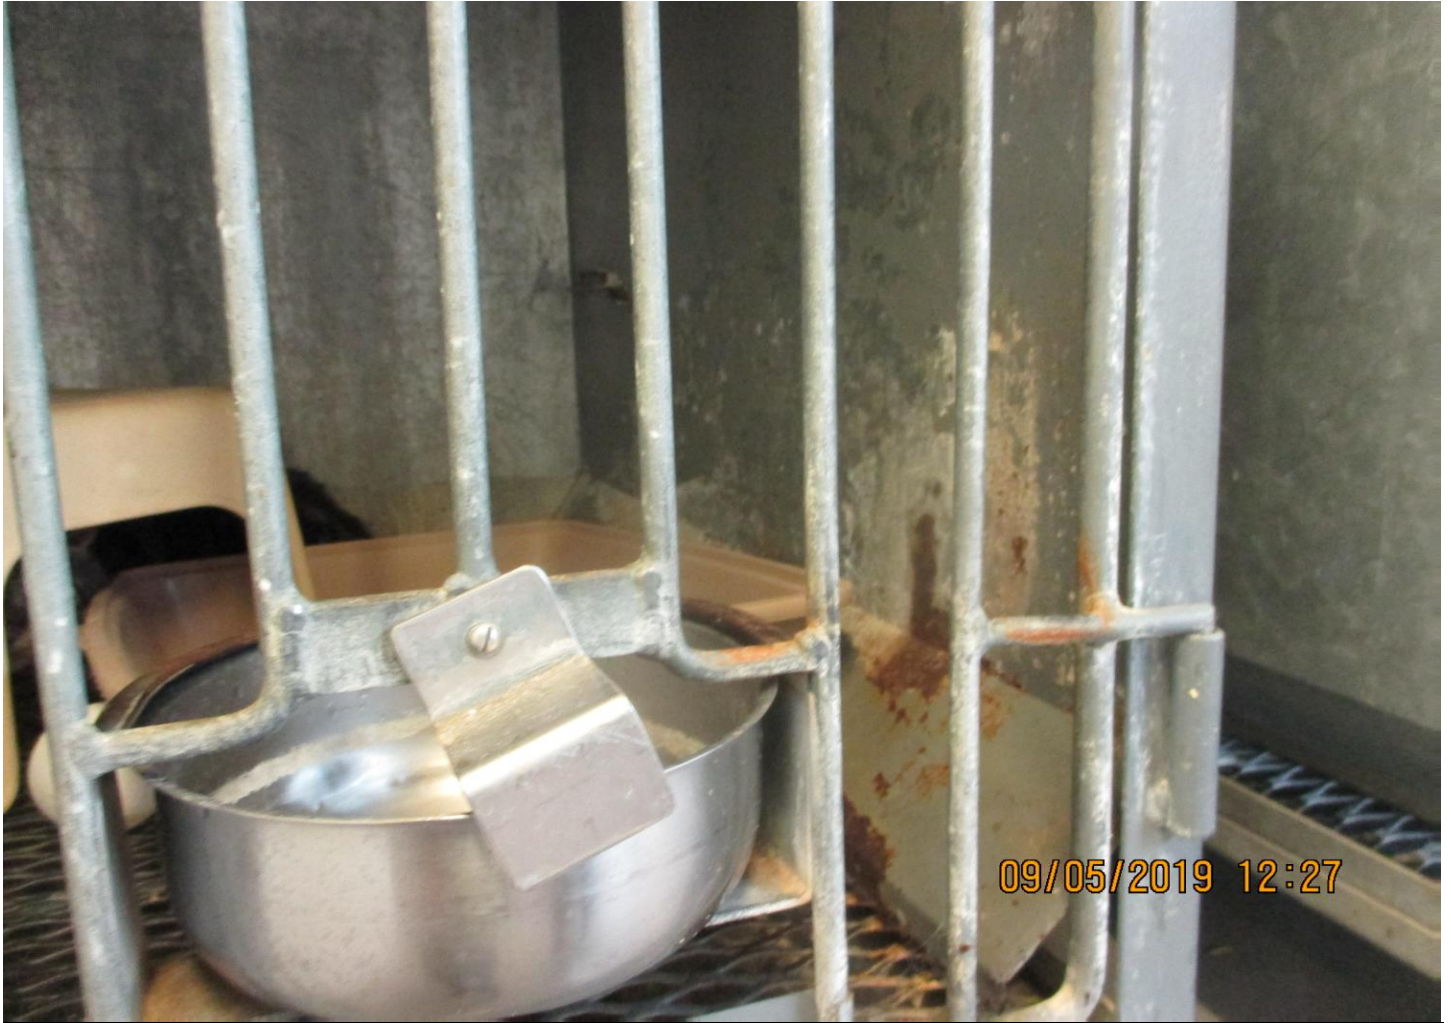
CFR : 3.1(c)(1)

Cat enclosure with rust

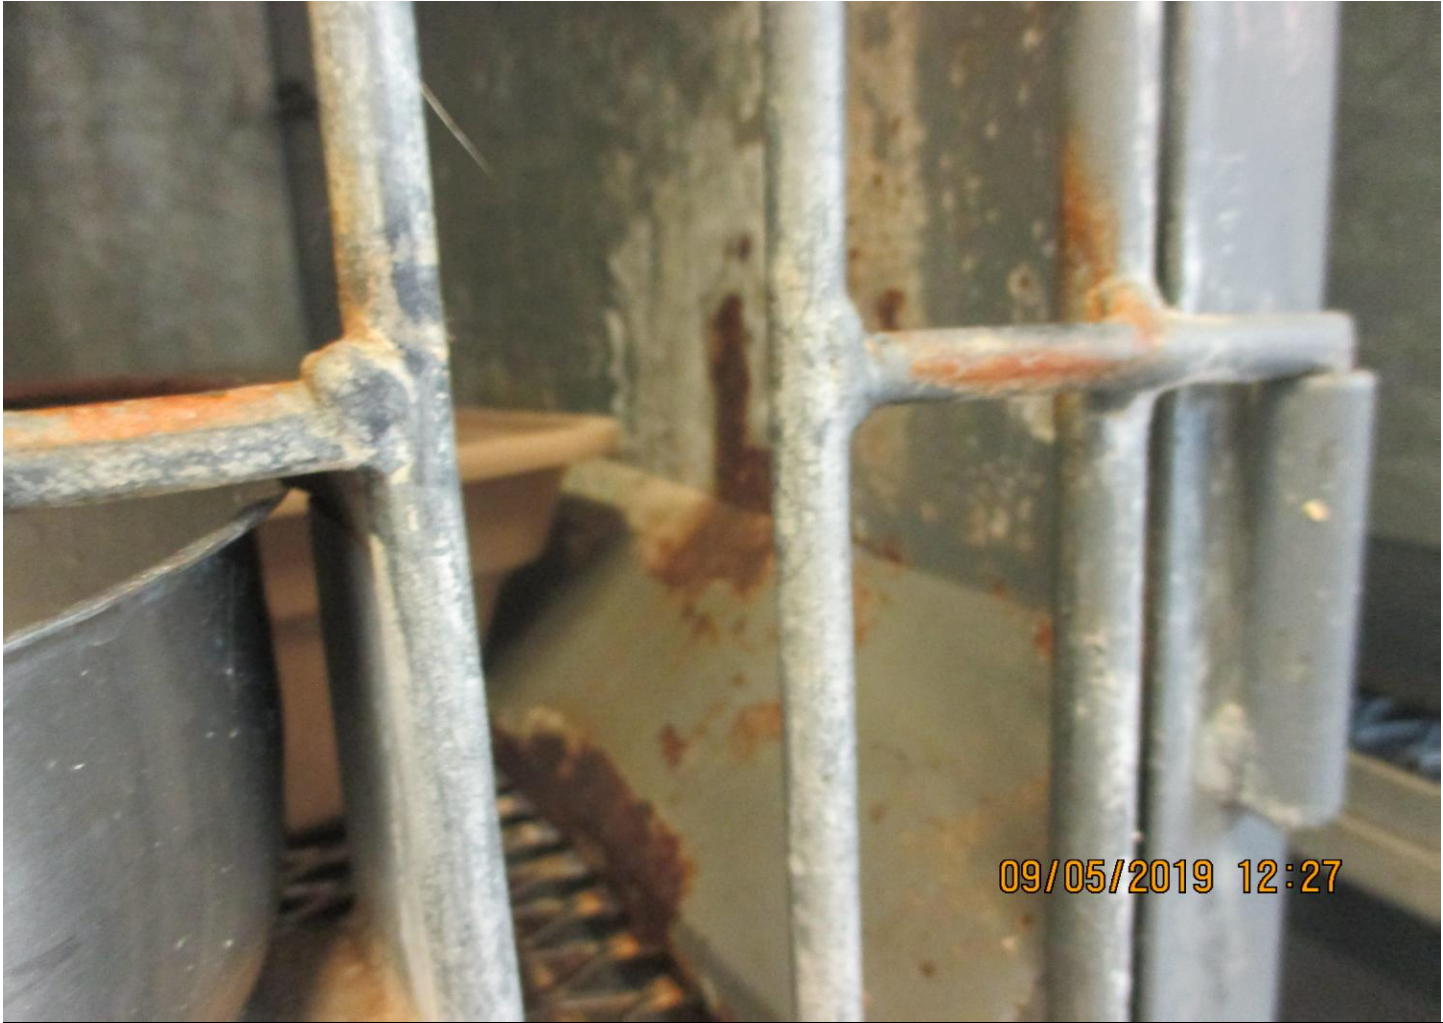
CFR : 3.1(c)(1)

Close up of rust in cat enclosure.

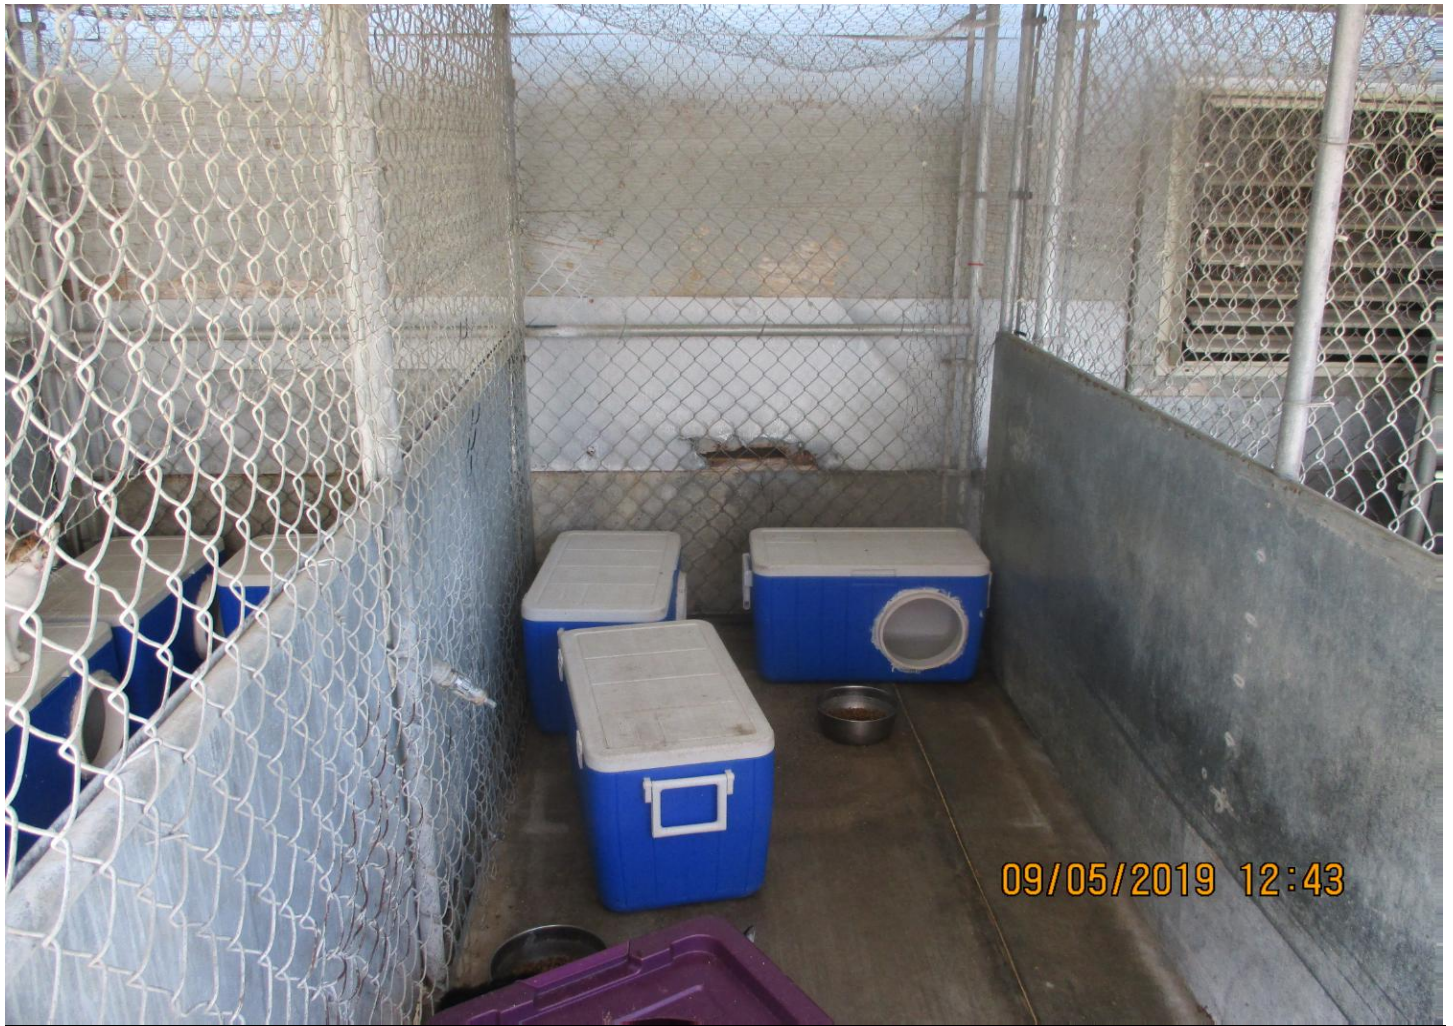
CFR : 3.6(a)(2)(i)

Social housing for cats - back wall behind chainlink has large gap in metal with sharp edges

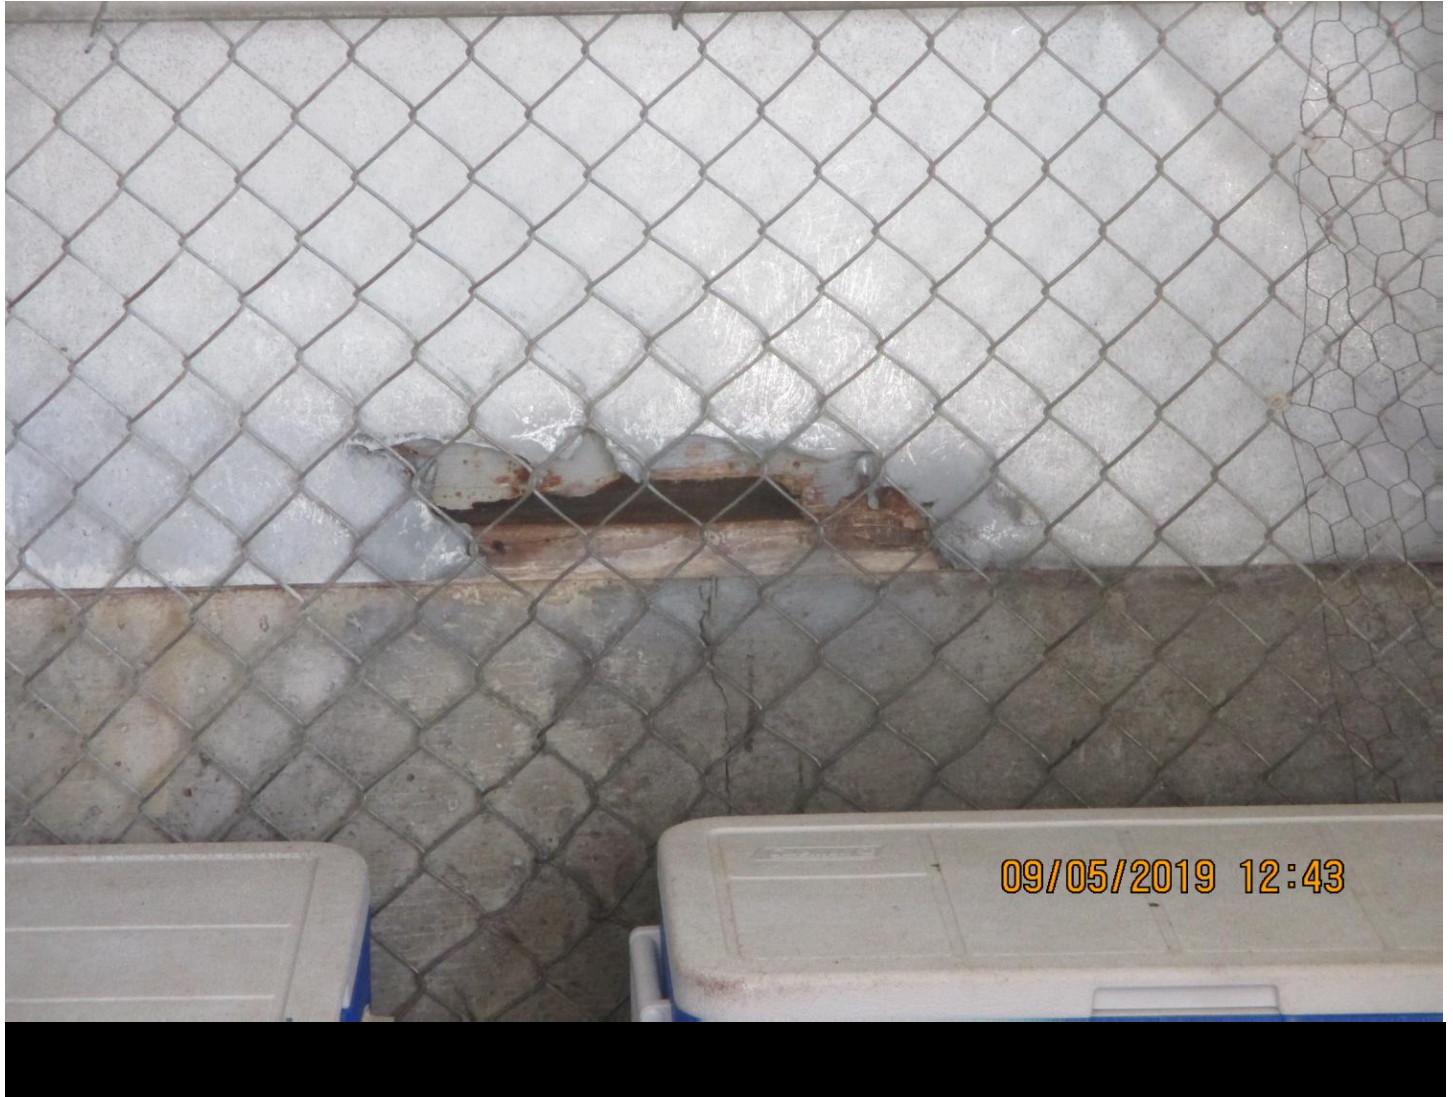
Close up: Social housing for cats - back wall behind chainlink has large gap in metal with sharp edges

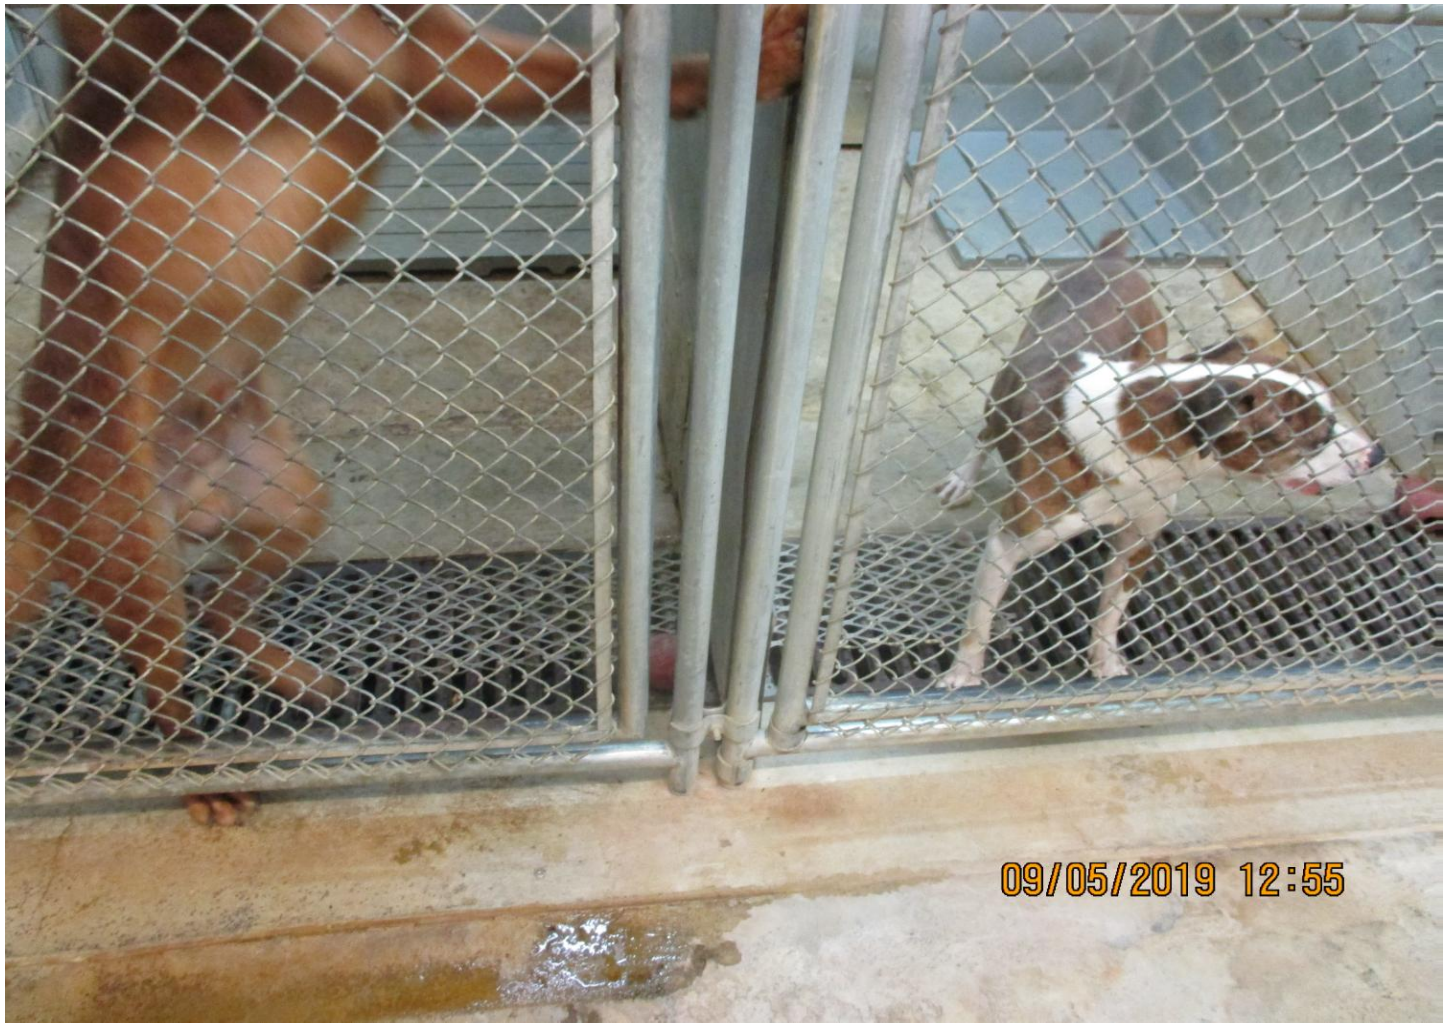
CFR : 3.6(a)(2)(i)

Dogs standing on patched metal grate mesh over floor drain that has sharp edges.

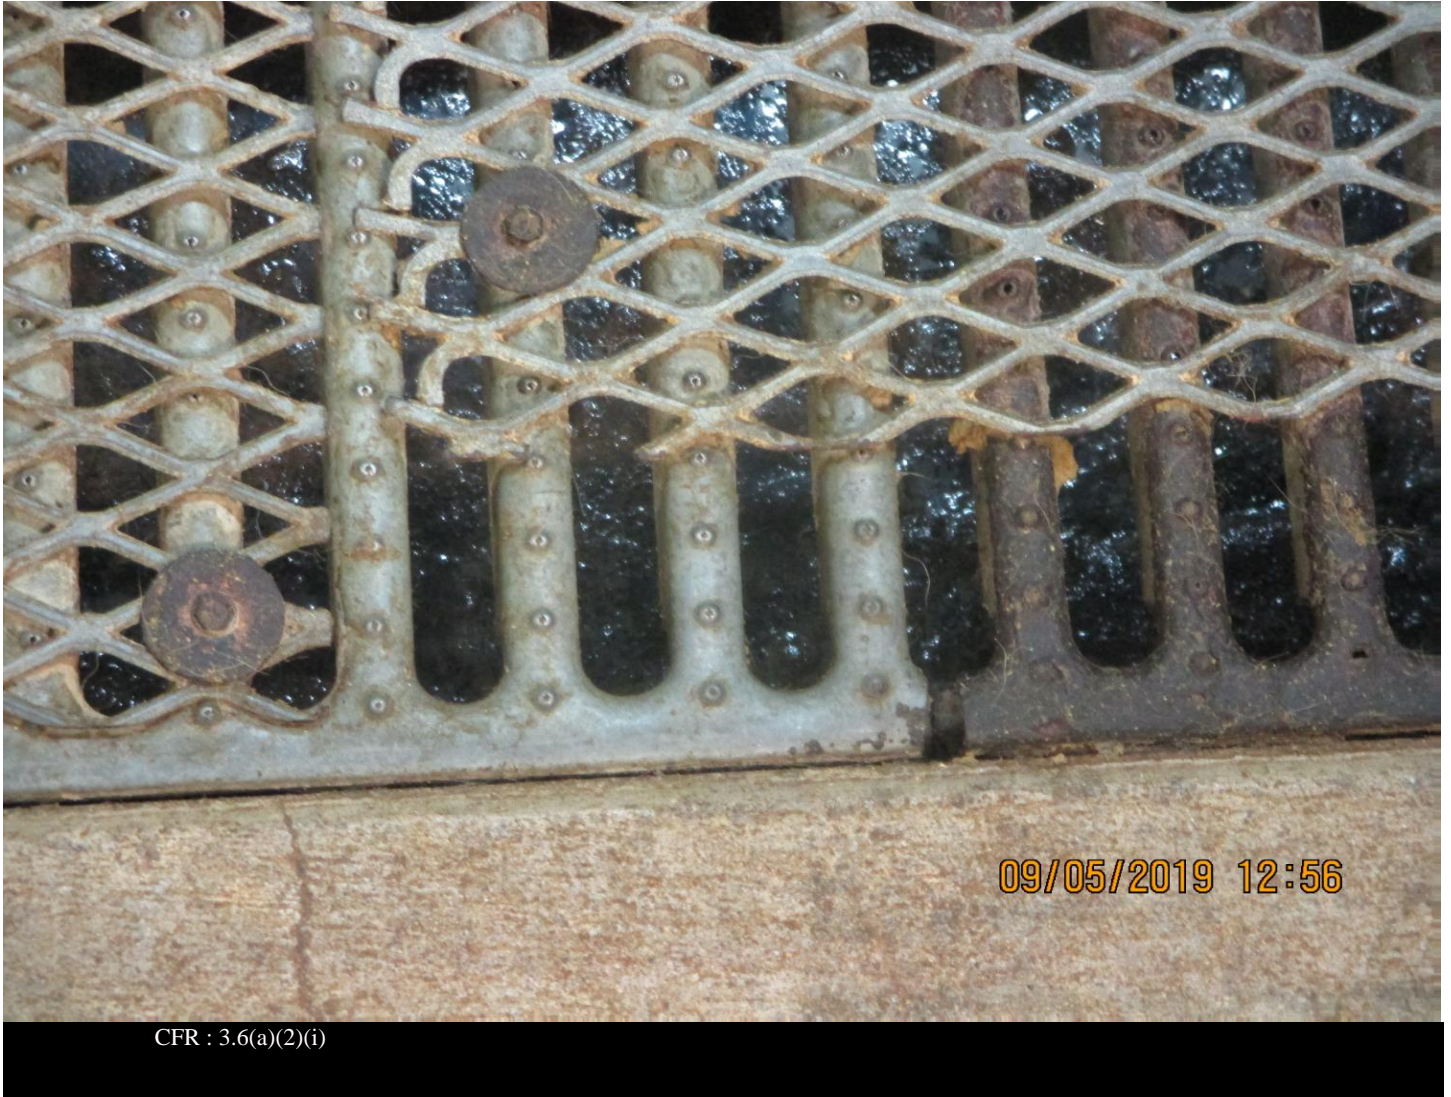
CFR : 3.6(a)(2)(i)

Close up of patched metal grate mesh over floor drain that has sharp edges.

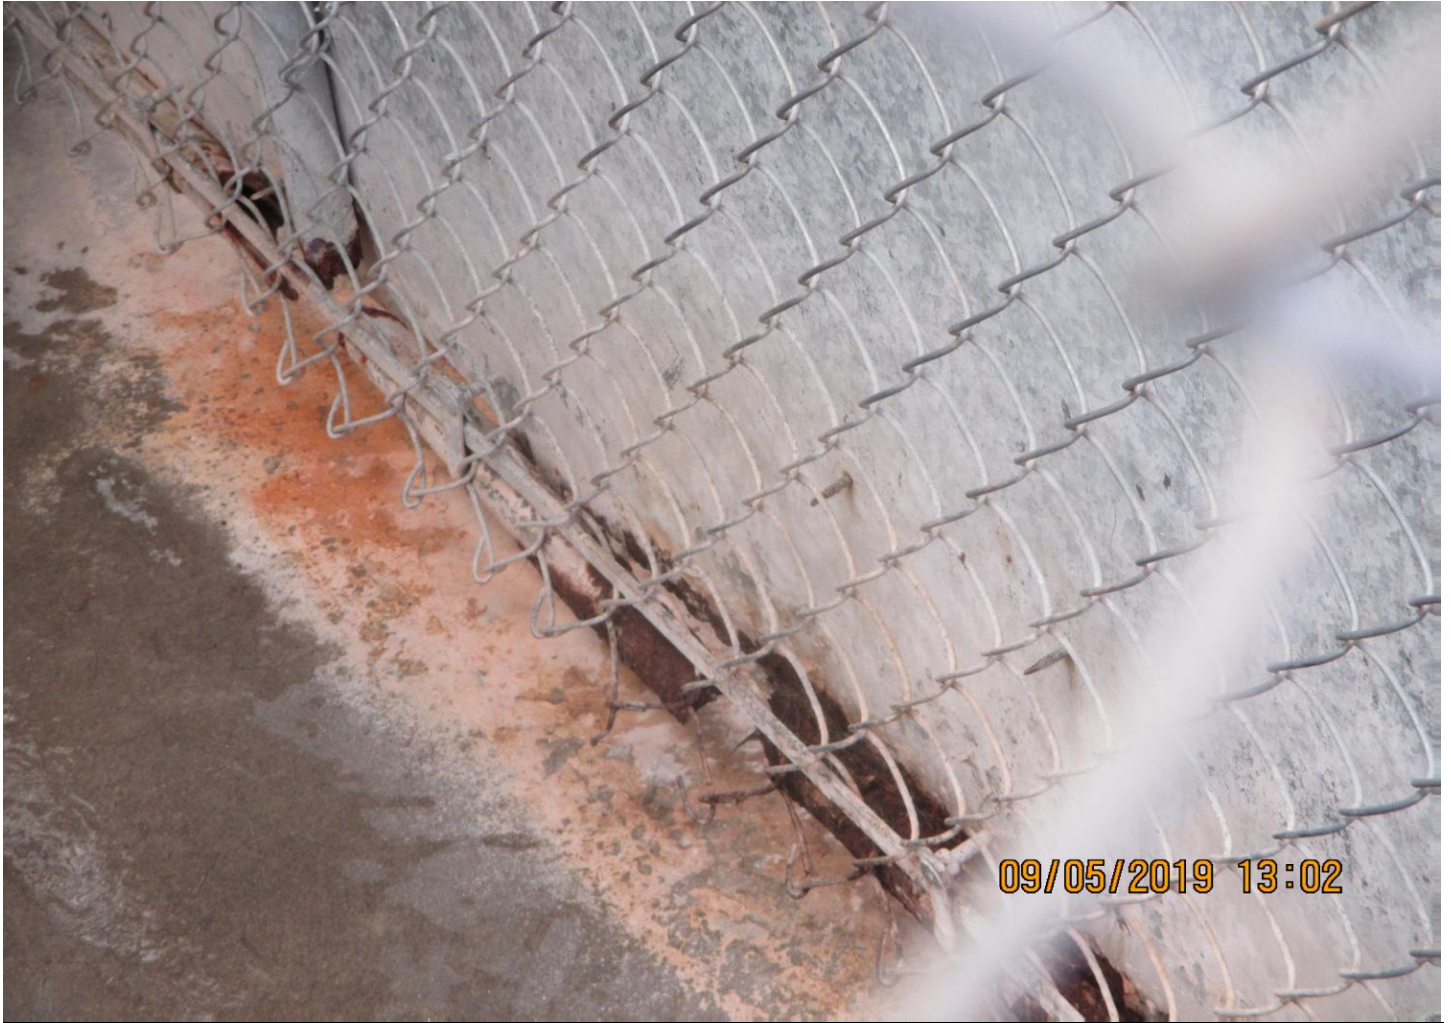
CFR : 3.1(c)(1)

In dog run example 1, rusted wall-support pipe behind chainlink.

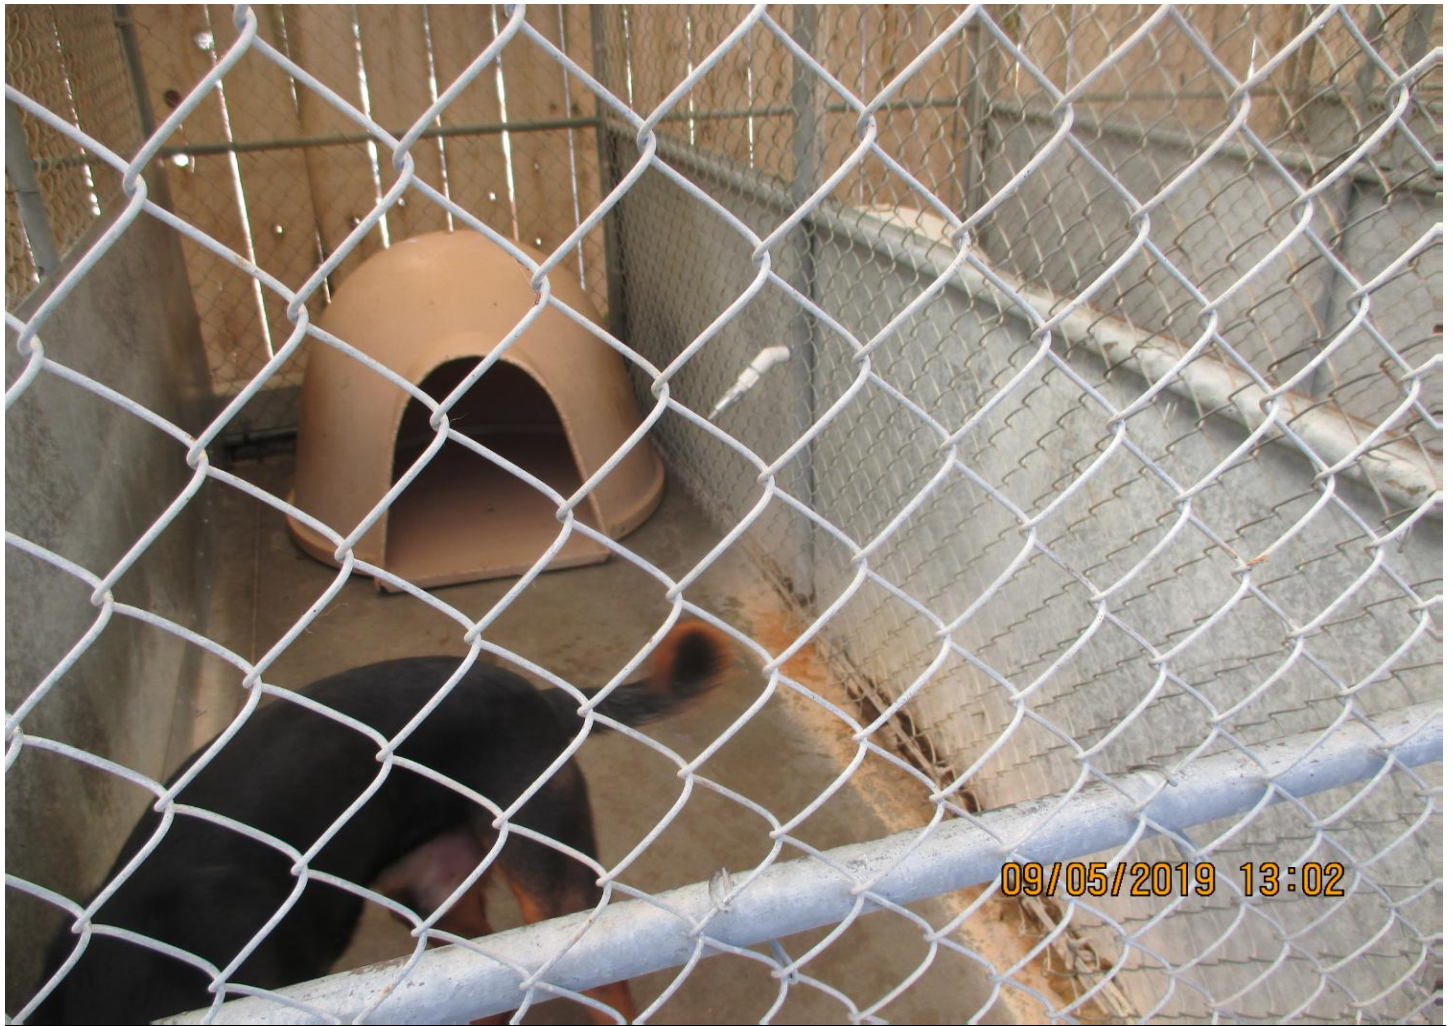
CFR : 3.1(c)(1)

In dog run example 1, rusted wall-support pipe behind chainlink.

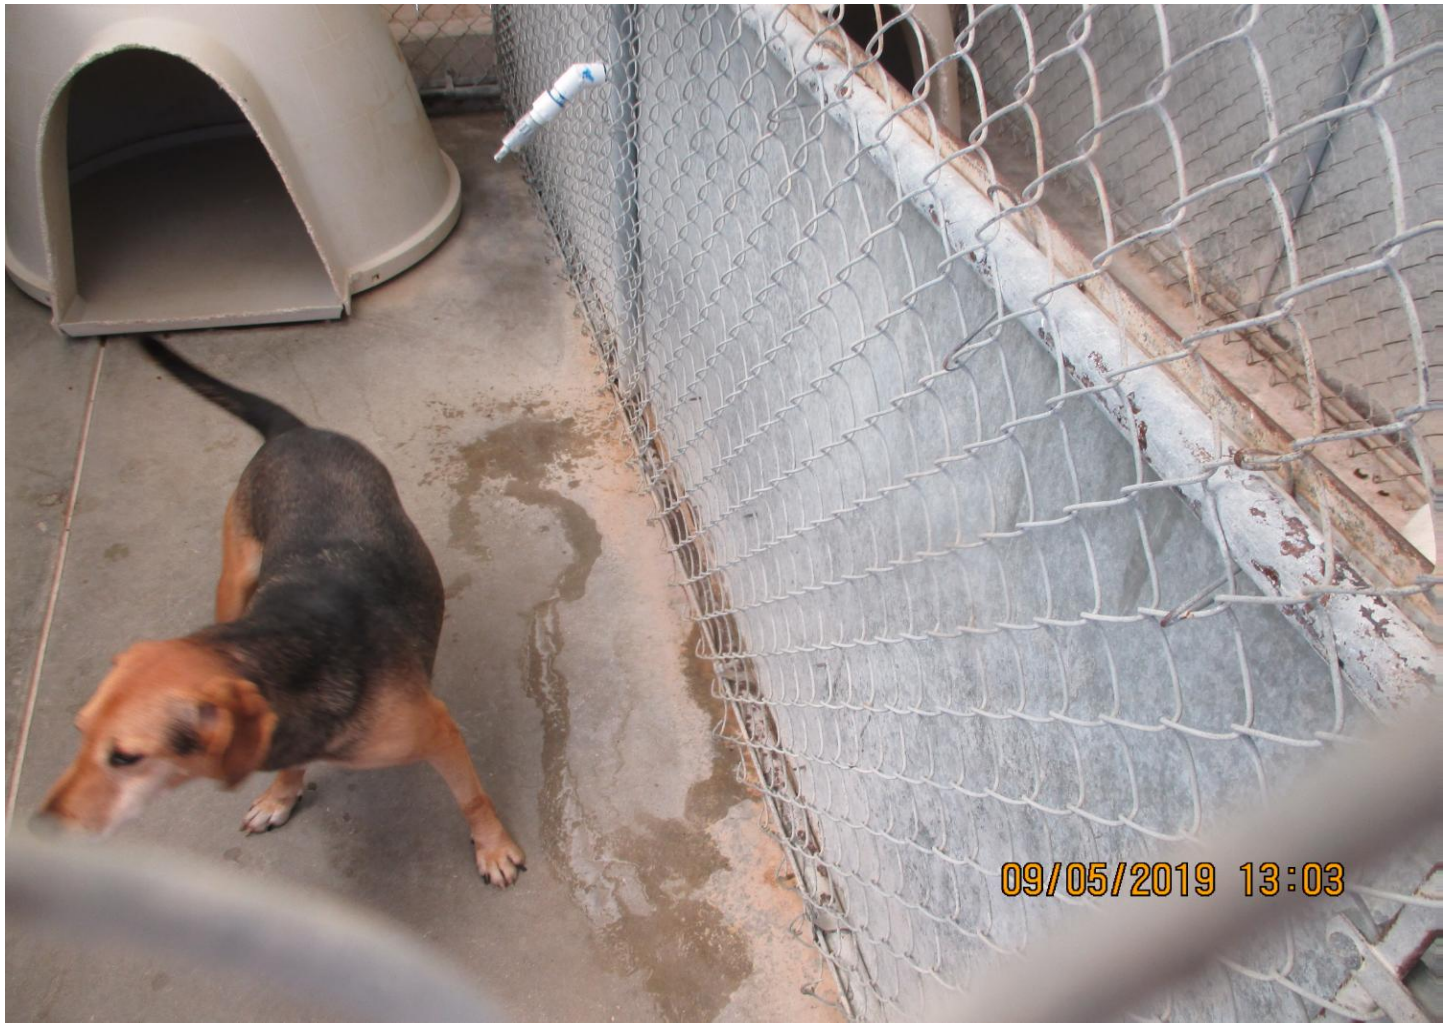
CFR : 3.1(c)(1)

In dog run example 2, rusted wall-support pipe behind chainlink.

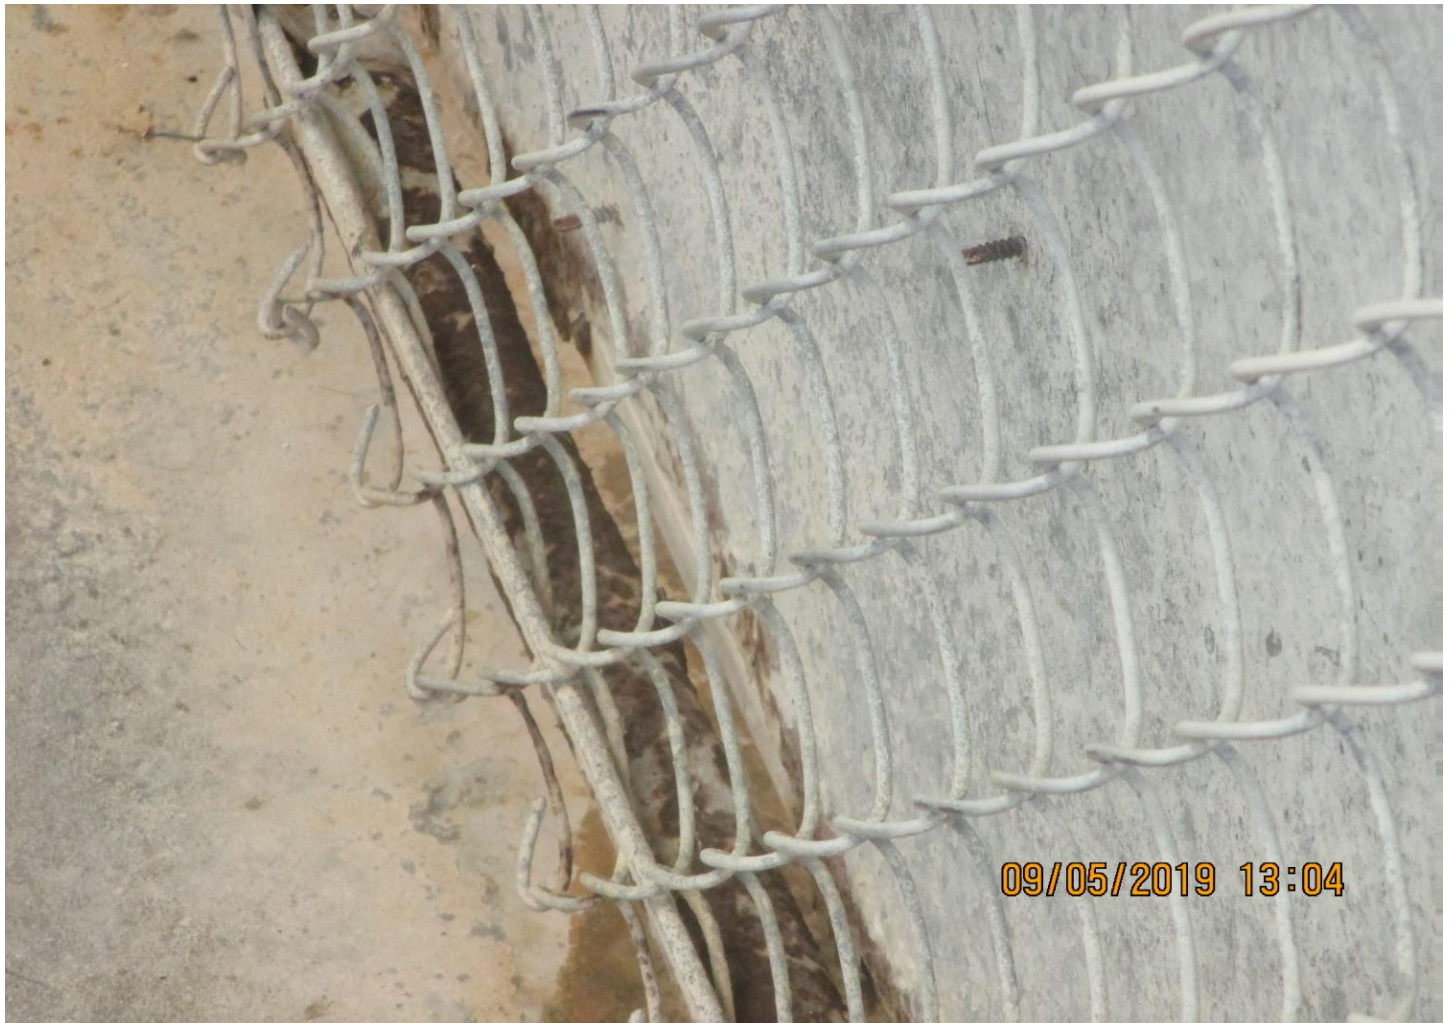
CFR : 3.1(c)(1)

In dog run example 2, rusted wall-support pipe behind chainlink.

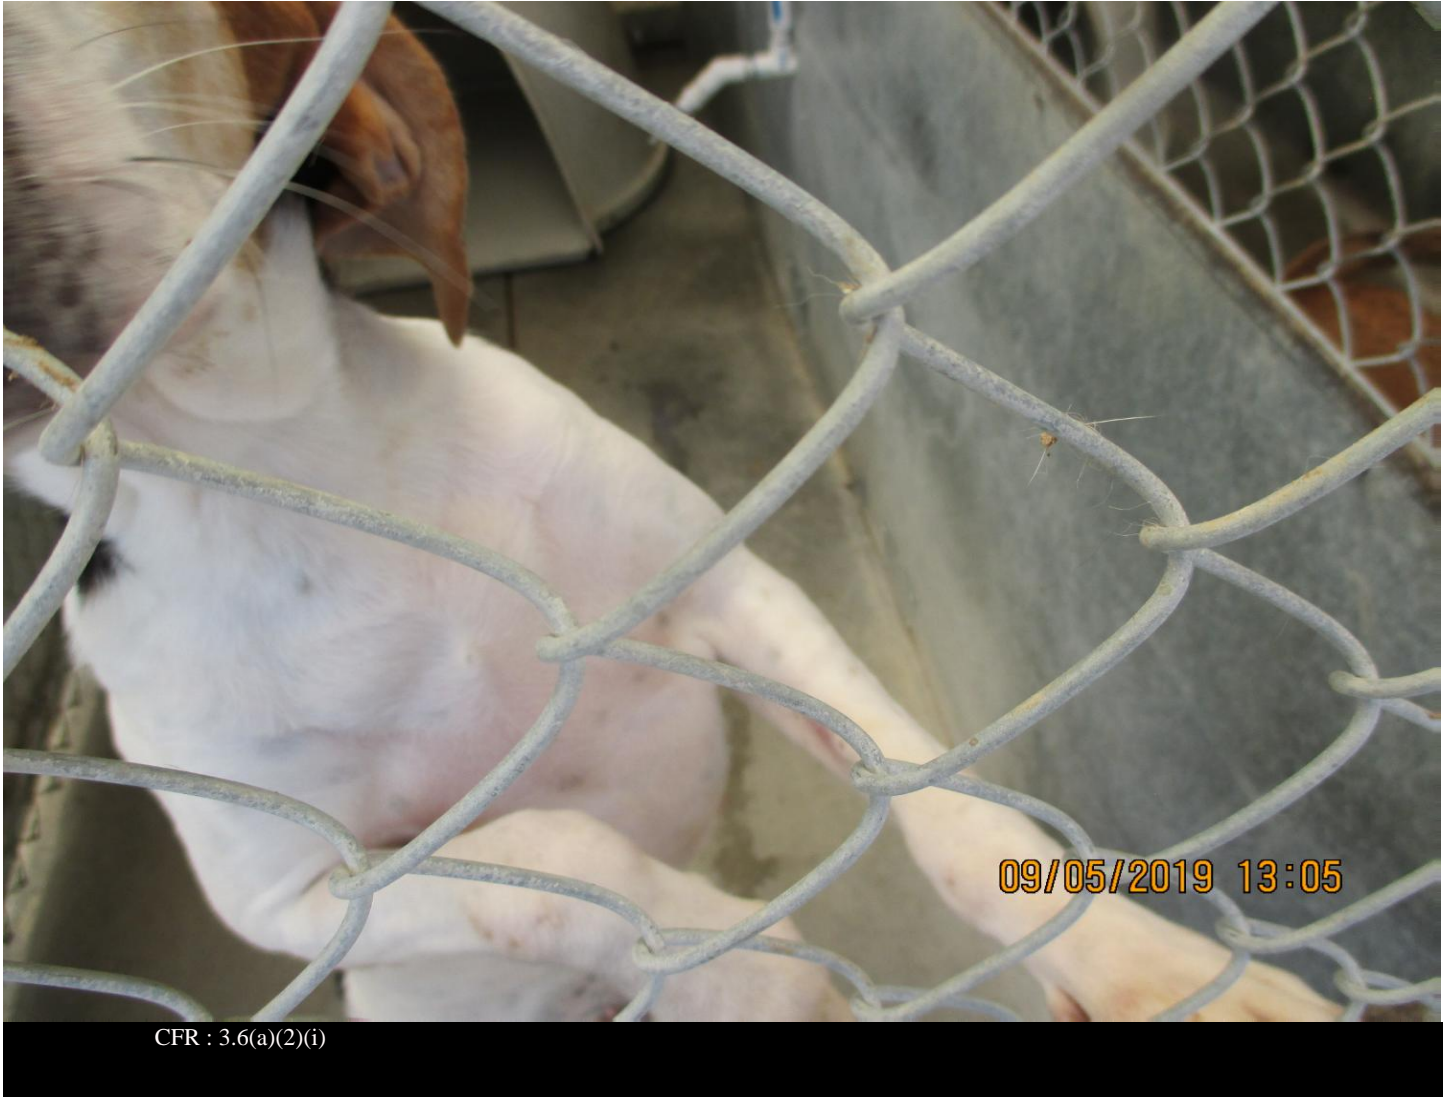
Sharp point protruding from wall of dog run, visible just to the right of the dog's shoulder, near the floor.

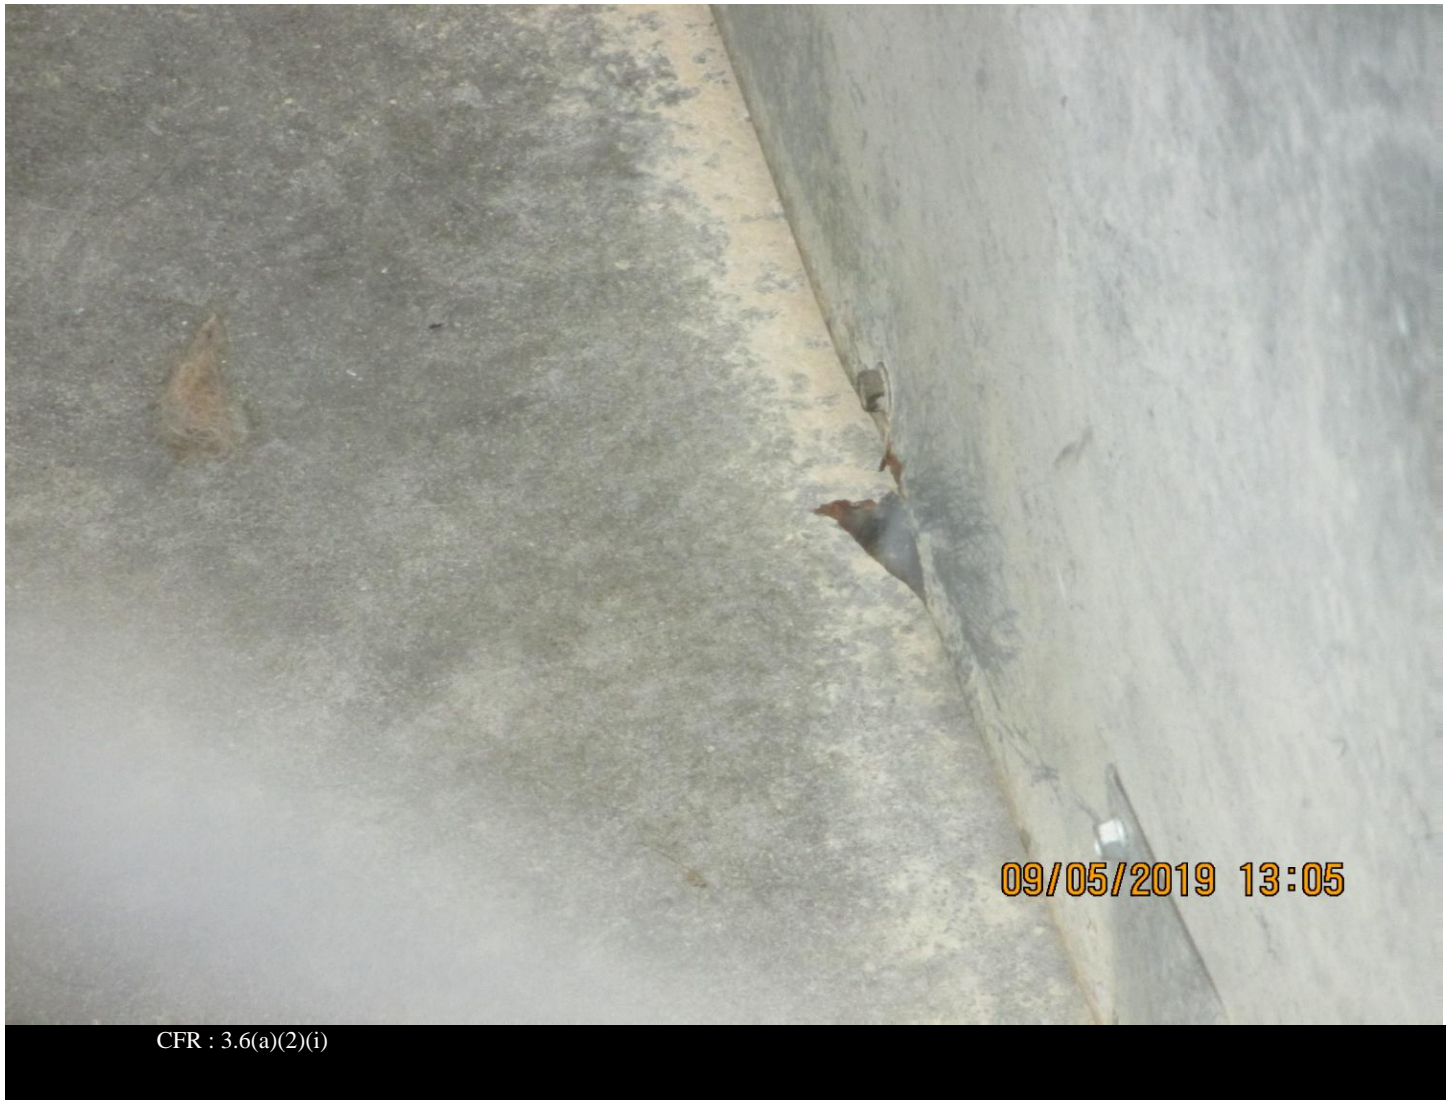
Close-up of sharp point in a dog run - bent metal corner near the floor.

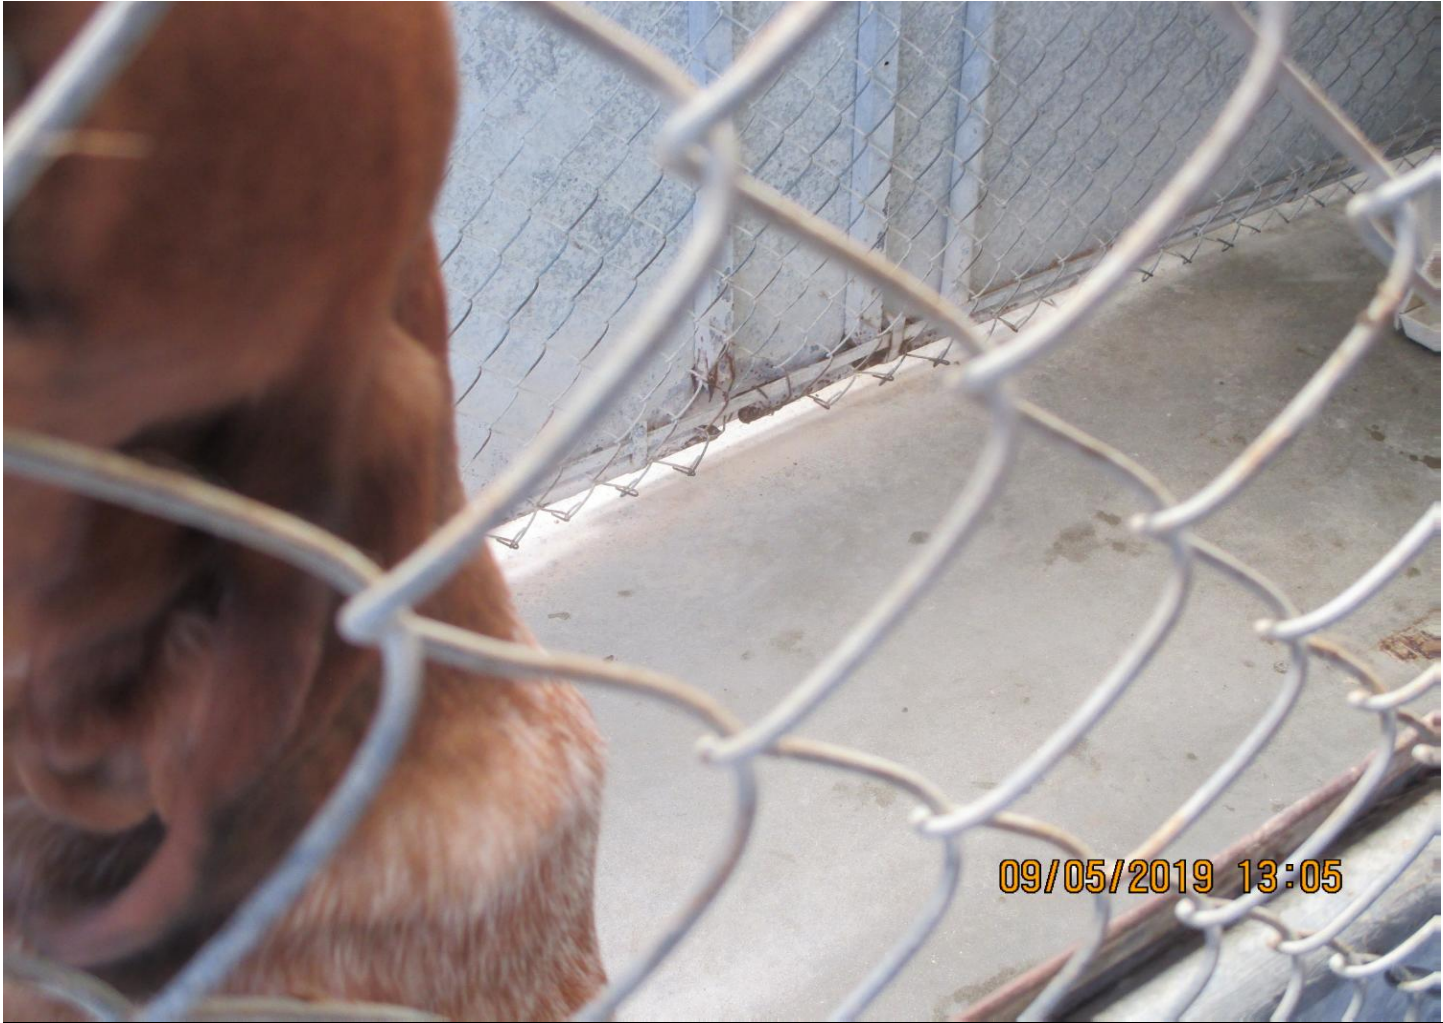
CFR : 3.1(c)(1)

In dog run example 3, rusted wall-support pipe behind chainlink.

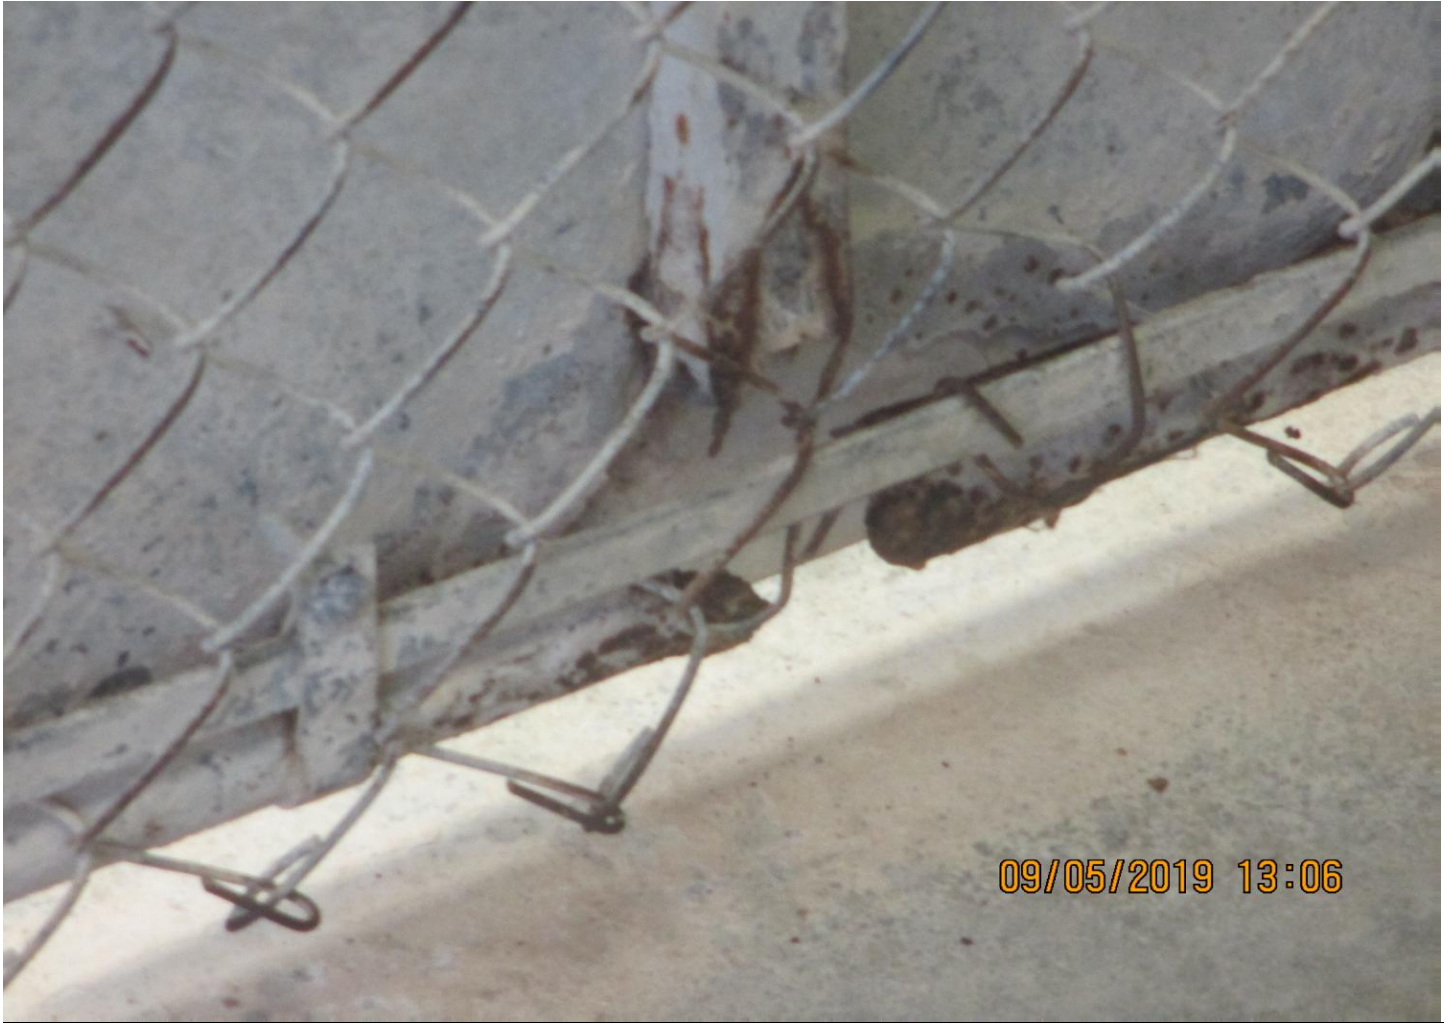
CFR : 3.1(c)(1)

Close-up: In dog run example 3, rusted wall-support pipe behind chainlink.
