**Date and Time:** 7/5/2022 9:08 AM **Legal Name:** Experimentica Ltd

**Inspection No:** 2016090000804713 **Facility Name:** Experimentica Ltd

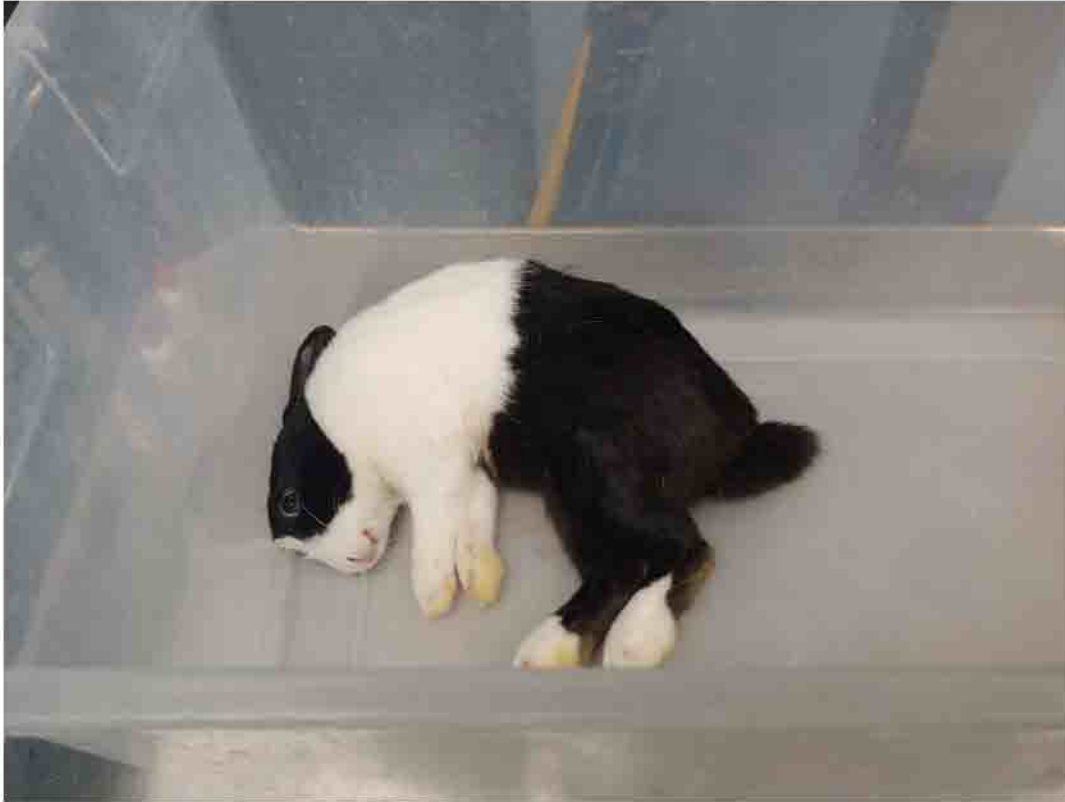
CFR:2.31(d)(5)

**Description:** Rabbit recovering from anesthesia without monitoring.

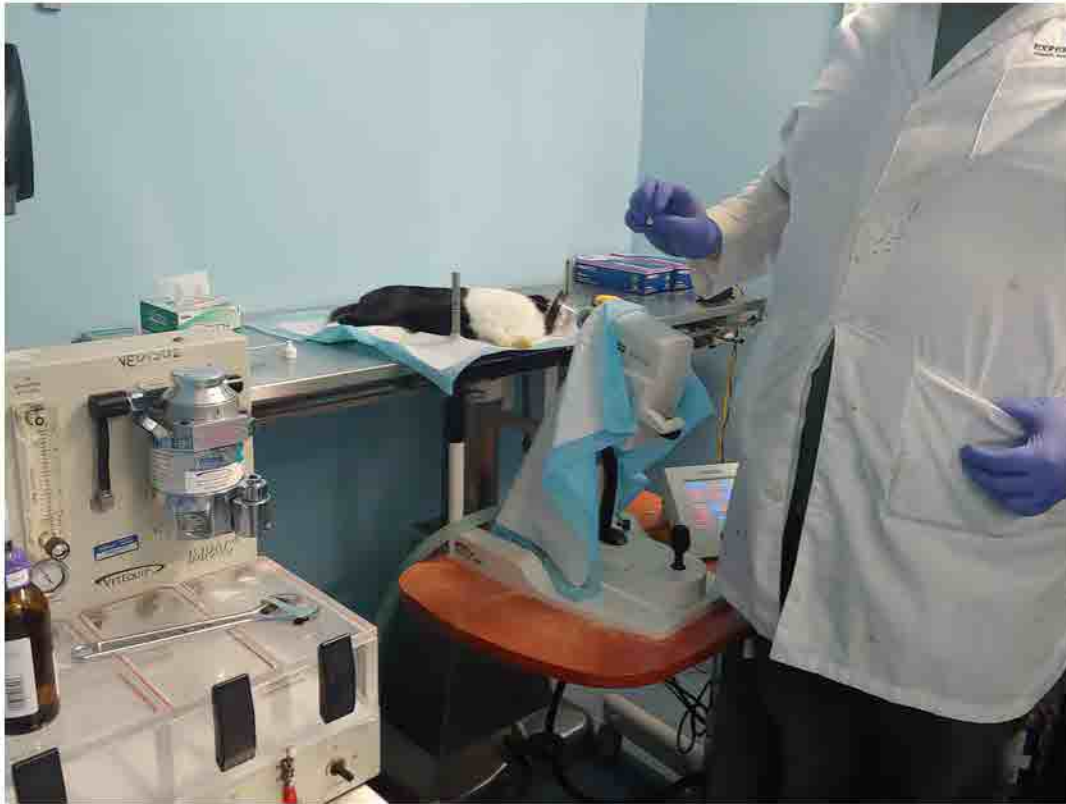
CFR:2.31(d)(5)

**Description:** One of three rabbits in various stages of anesthesia being monitored by one individual.

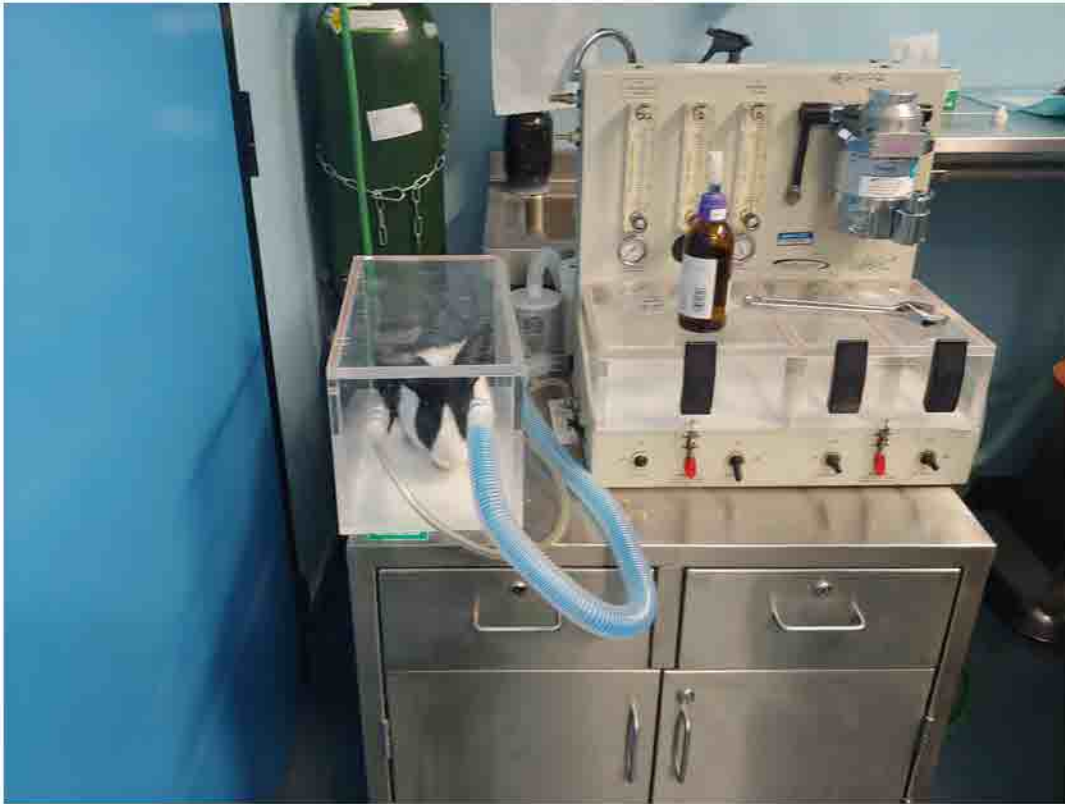
CFR:2.31(d)(5)

**Description:** Third rabbit in induction chamber.

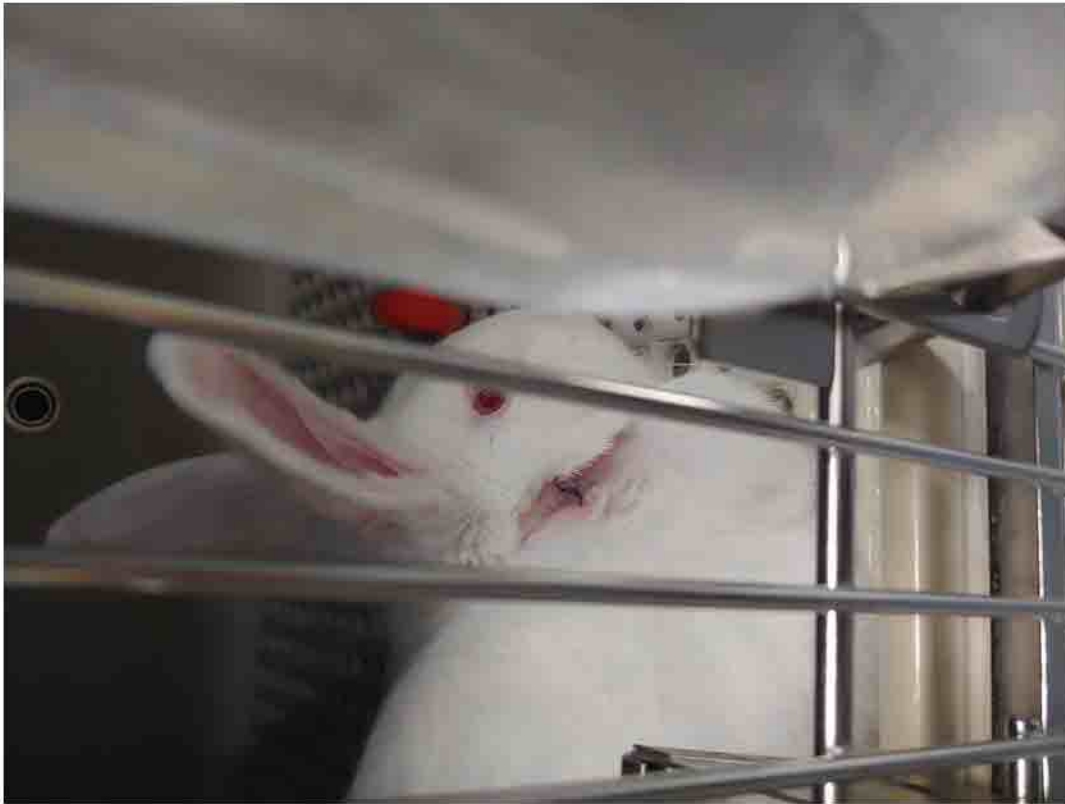
CFR:2.31(d)(5)

**Description:** Rabbit that had recently undergone 3rd infusion pump placement
