Certificate: 93-A-0215

Legal Name: AgBio Company

Inspection No: 2016090000793367

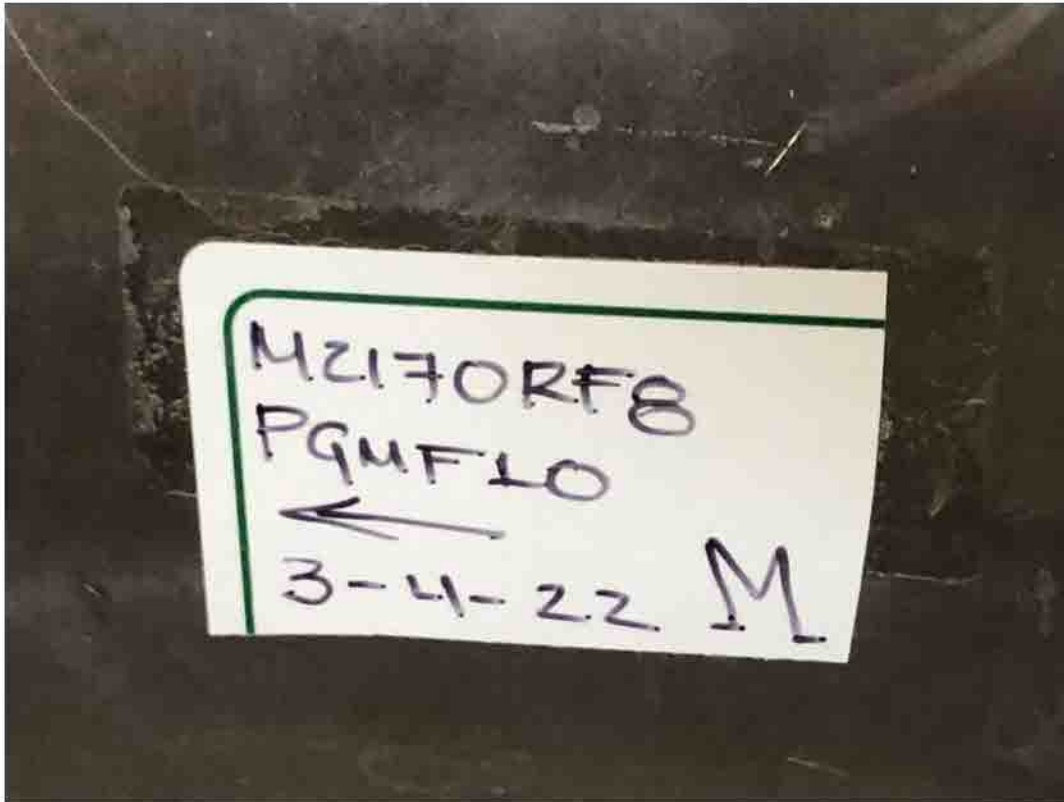
CFR:2.40(b)(3)

Description: Label for the enclosure, identifying the rabbit with the crusty eye. Also no additional treatment notes on the cage front that the issue had been identified and addressed.

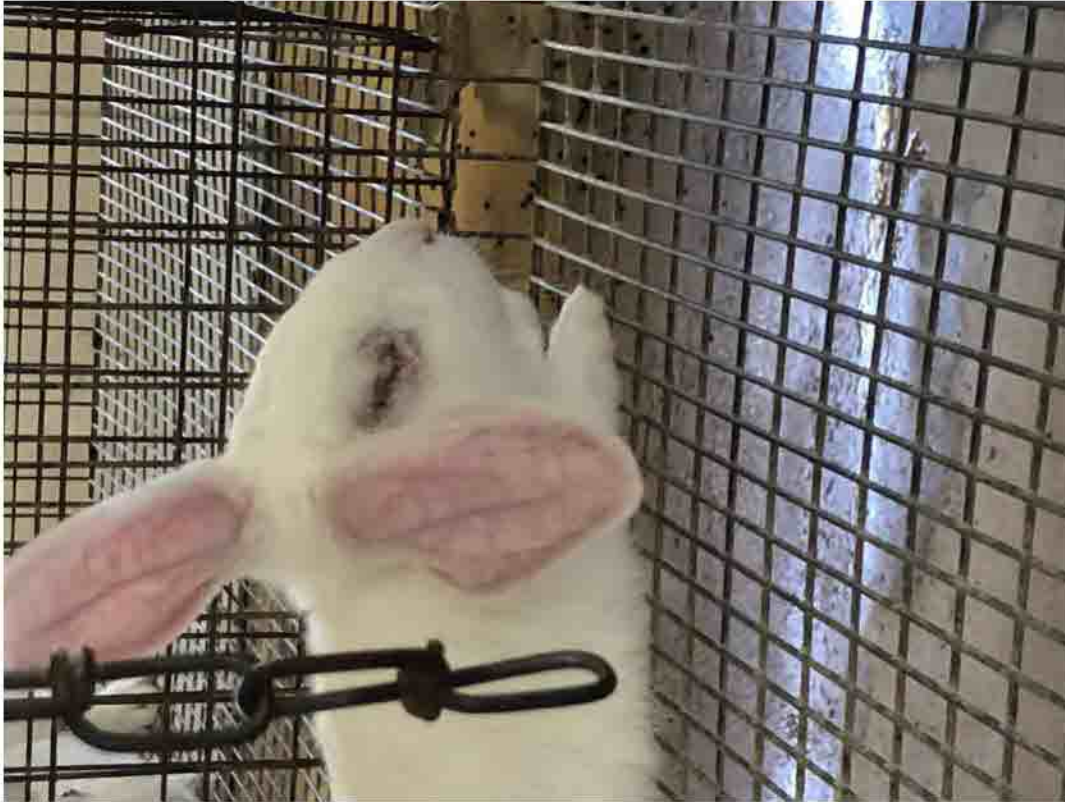
CFR:2.40(b)(3)

Description: Picture of rabbit with crusty right eye and eye surface that appeared white.
