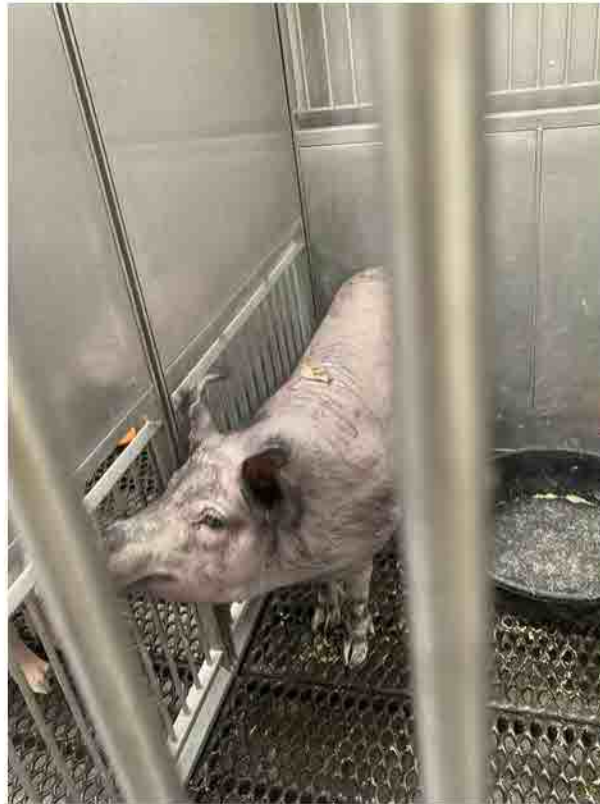
CFR:2.131(b)(1)

Description: One pig on an approved protocol had ulcerations along his back with redness and hyperpigmentation above and below the ulcerations. The facility representative stated they developed in response to thermal injury due to electric warmers used during surgery to support temperature regulation. Initially a water circulating heating pad was used but was replaced with the electric heating pad due to water leakage.

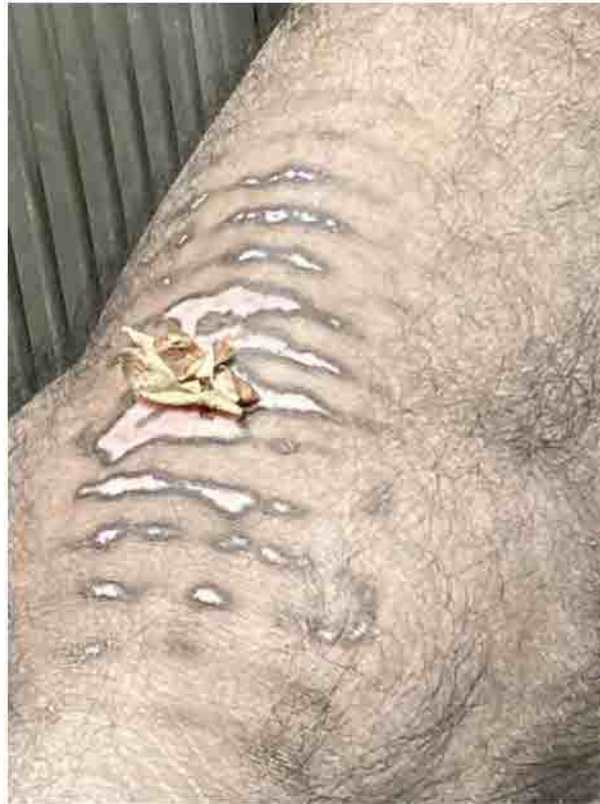
CFR:2.131(b)(1)

Description: One pig on an approved protocol had ulcerations along his back with redness and hyperpigmentation above and below the ulcerations. The facility representative stated they developed in response to thermal injury due to electric warmers used during surgery to support temperature regulation. Initially a water circulating heating pad was used but was replaced with the electric heating pad due to water leakage.
