Certificate: 74-R-0161 Legal Name: Equitech-Bio Inc.

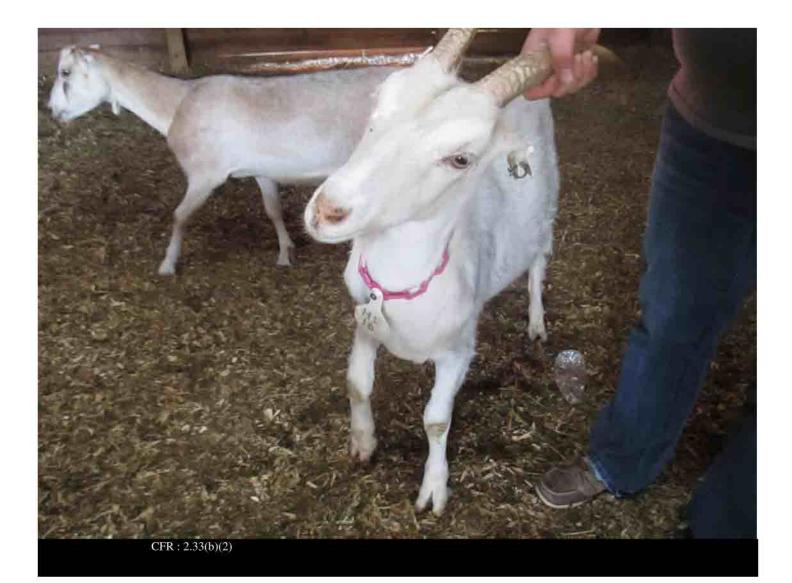
Photographer: K. CAMPITELLI Date and Time: 10-OCT-19 Inspection No: 2016082569627591 Description: White male goat HL10 unable to bear weight on the right front leg.

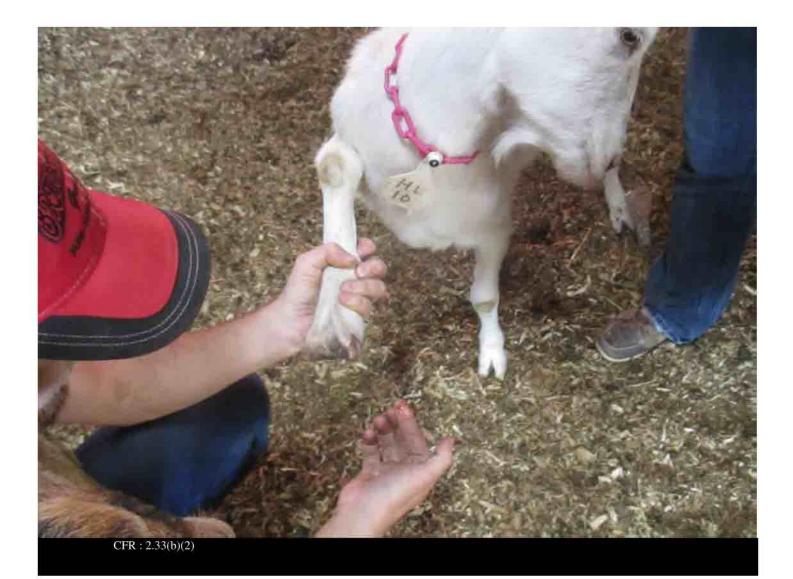
Close-up of right front leg of male goat HL10. Some bloody/purulent discharge was present on the hoof.

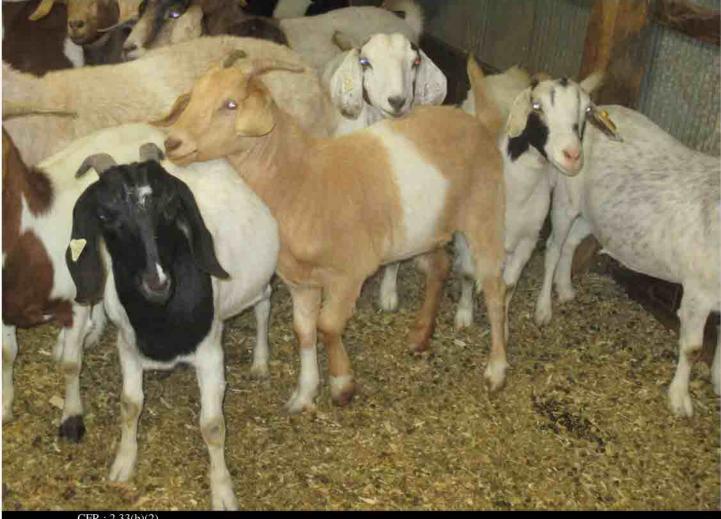
Tan & white male goat 565 toe-touching on the left front leg while standing. This animal was unable to bear weight on this leg while moving.

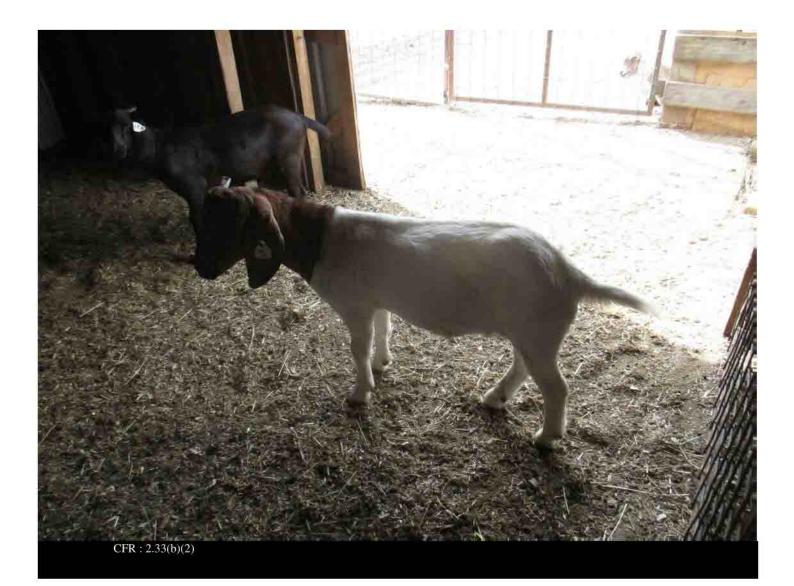
White & brown male goat HL11 toe-touching/unable to bear weight on the right rear leg while moving. Also visible is black male HL2 who was toe-touching and unable to bear weight on the left front while moving.

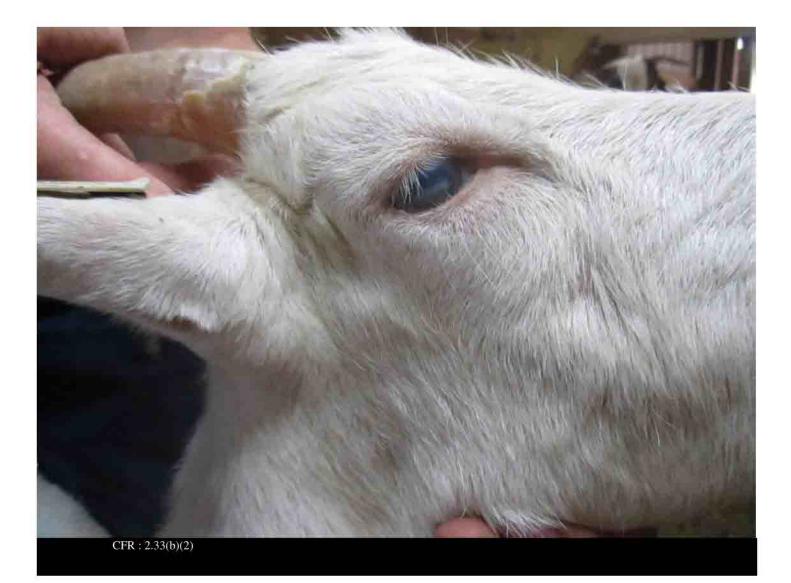
Photographer: K. CAMPITELLI	
Date and Time: 10-OCT-19	Certificate: 74-R-0161
Inspection No: 2016082569627591	Legal Name:
Description: White male goat 0624 with a horizontal linear milky white opacity in the center of	Equitech-Bio Inc.
the right eye.

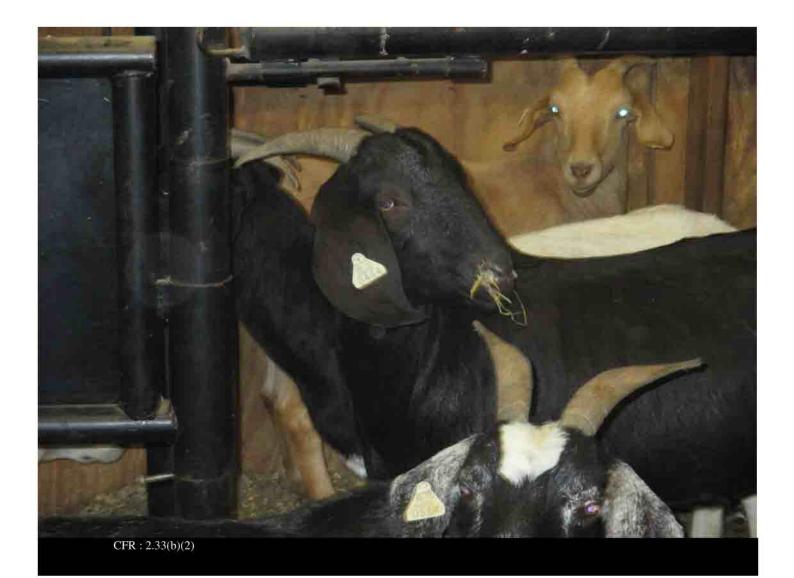
Photographer: K. CAMPITELLI Date and Time: 10-OCT-19 Inspection No: 2016082569627591 Description: Black female goat 464 with thick green discharge from both nares.

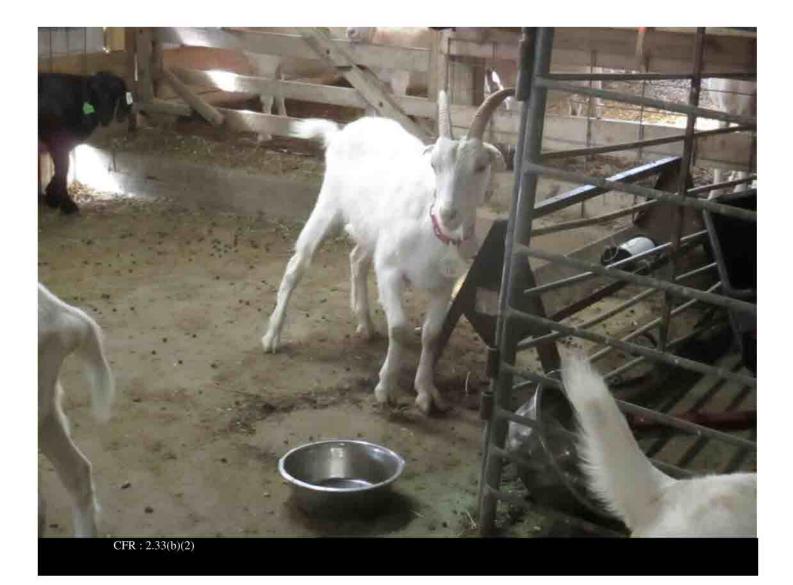
White male goat HL10 unable to bear weight on the right front leg. Also visible is black male HL2 toe-touching/unable to bear weight on the left front leg.

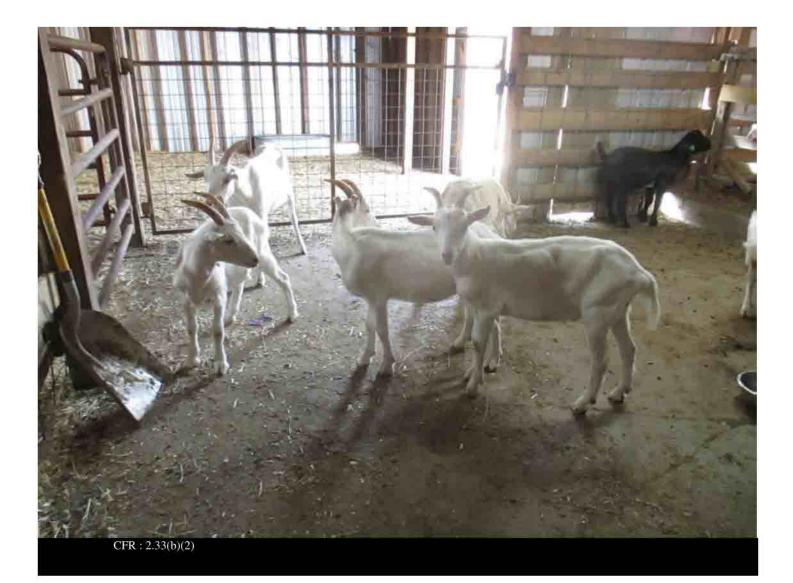
An overview of a group of animals which were identified in need of veterinary care during the inspection; at least 7 animals are visible in this photo. Additionally, at least 2 others were also separated during the inspection and are captured in other photos. They were held in these areas to facilitate examination by the veterinarian and/or initiation of treatment according to the PVC during the inspection.
